Thermal Audit – Mercy Gate Church Box Elder

Address: 400 225th St, Box Elder SD 57719

Date: 17 March 2023 @ 8pm (1 Hour After Sunset)

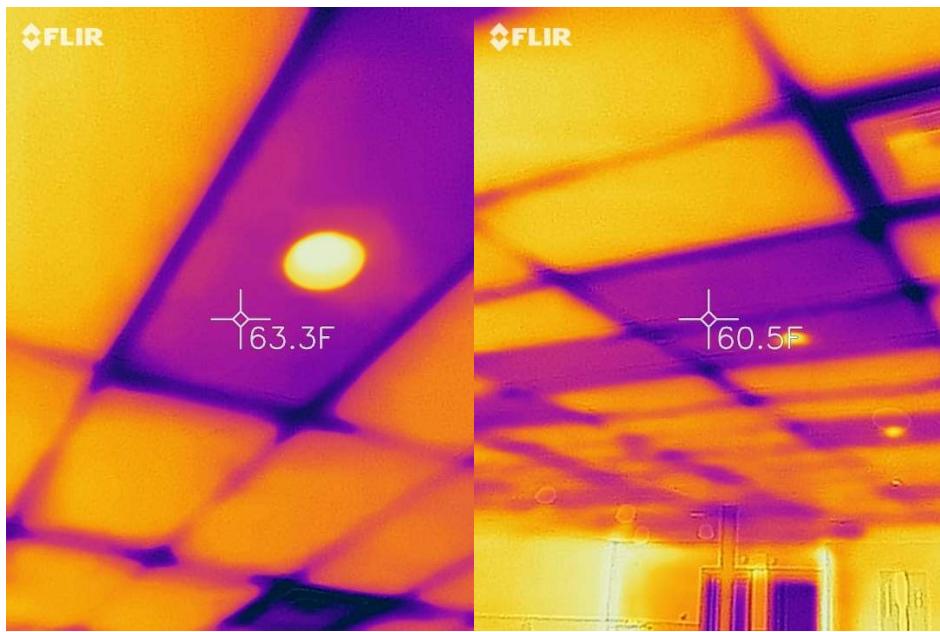
The Drop Ceiling is missing insulation in various places, this has a small impact on energy loss (Figure 1-Light Panel - Drop Ceiling). The original ceiling is the primary offender in energy loss. Most significant is the left ceiling above the stage (Figure 2-Left Ceiling Above Stage) and right ceiling in the right storage room (Figure 3-Right Storage Room Ceiling); another is the forward right support post (Figure 4-Front Right Support Post). The windows are in good condition, and the shutters further increase the R-value of the window openings.

Figure 1-Light Panel - Drop Ceiling

Insulating the attic space will improve the R-value of the worship hall. Replacing missing insulation in the drop ceiling will also help. One or the other is recommended, both would likely not provide a high return on investment over one or the other.

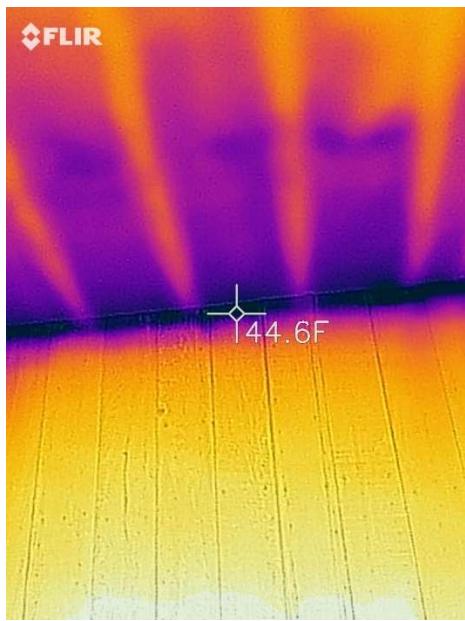
Figure 2-Left Ceiling Above Stage

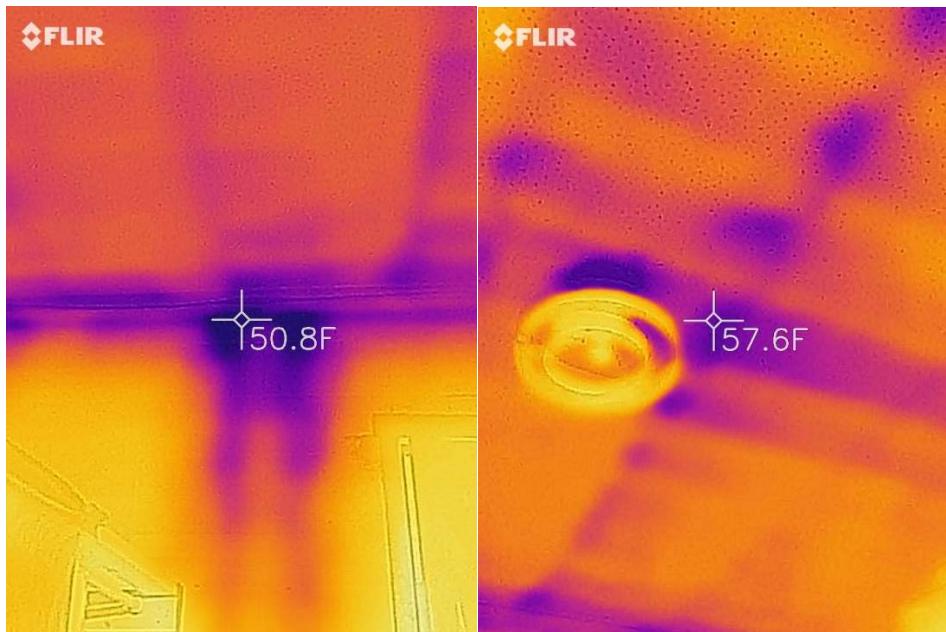
Figure 3-Right Storage Room Ceiling – Circular Fixture is the Light

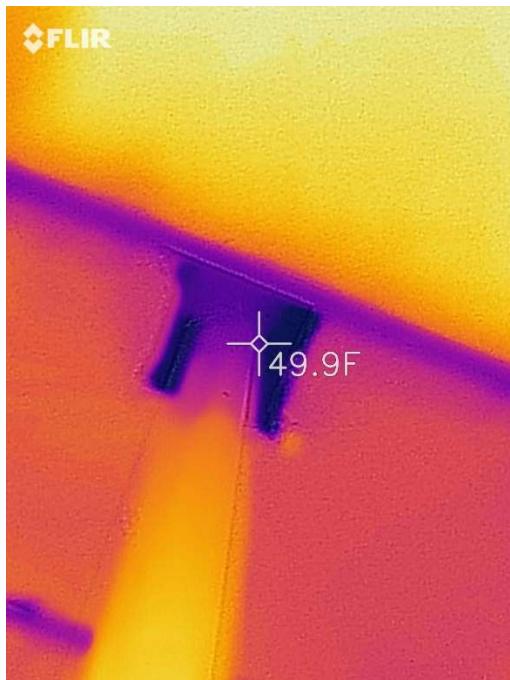
Figure 4-Front Right Support Post Drop Ceiling

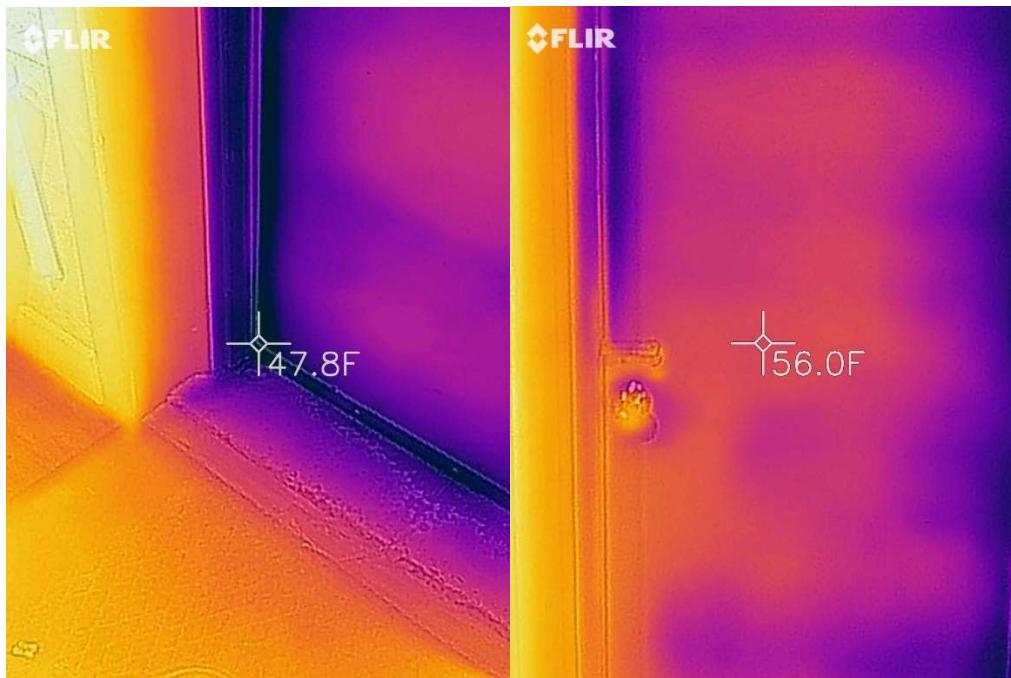
Both exterior doors have a high impact on energy loss (Figure 5-Worship Hall Doors).

Figure 5-Worship Hall Doors

Replacing or sealing the exterior doors will drastically improve efficiency in the Worship Hall.

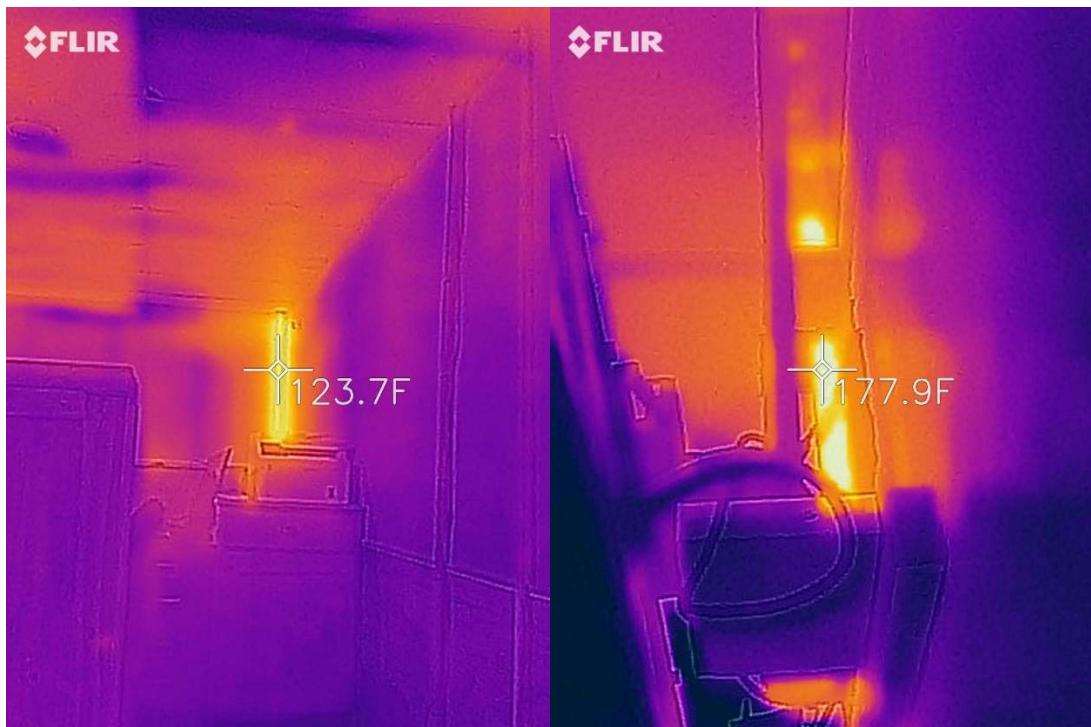
Boiler feed lines are 178*F and 124*F. Damage to human skin occurs in seconds above 140*F. accidental contact with the 178*F line is precluded by its location in the North ceiling behind the confidence monitor; recommend seeking the input of an expert as to safety of this line. The 124*F line is in the North West corner of the Worship Hall; recommend insulation to prevent accidental exposure which could lead to first degree burns.

Figure 6-Boiler Feed Lines

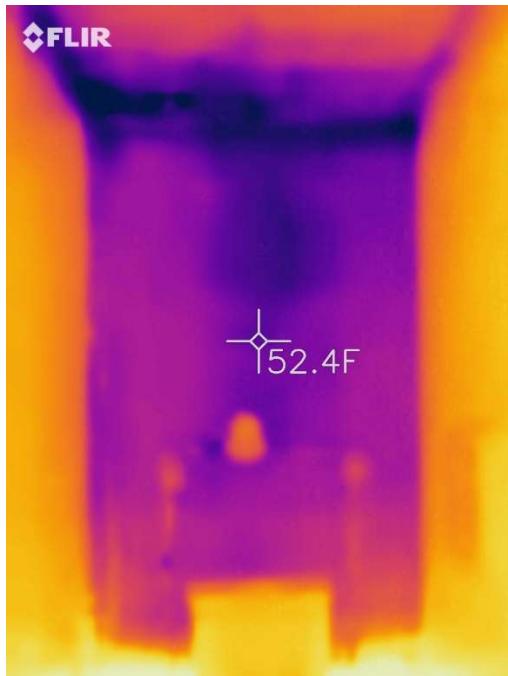
Exterior brick walls have a small impact on energy loss, specifically in the East wall and children's bathroom West wall. The foyer entry door could use a better seal. Ceilings are moderate energy loss points, especially in the children's bathroom and storage room.

Figure 7-Childrens Bathroom West Wall

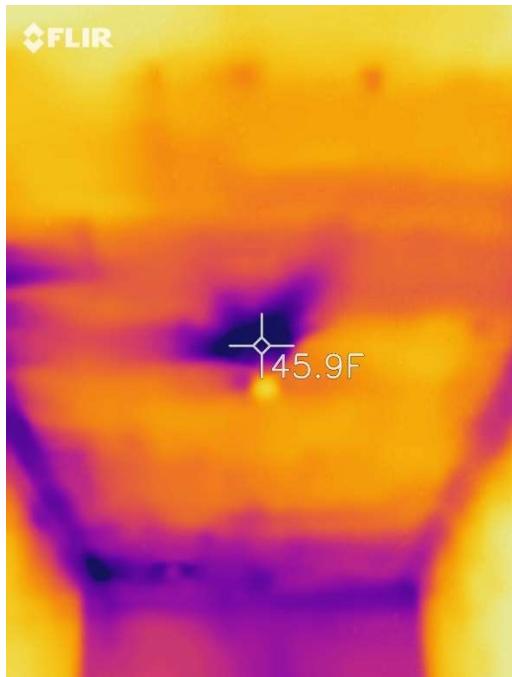
Figure 8-Children's Bathroom Ceiling

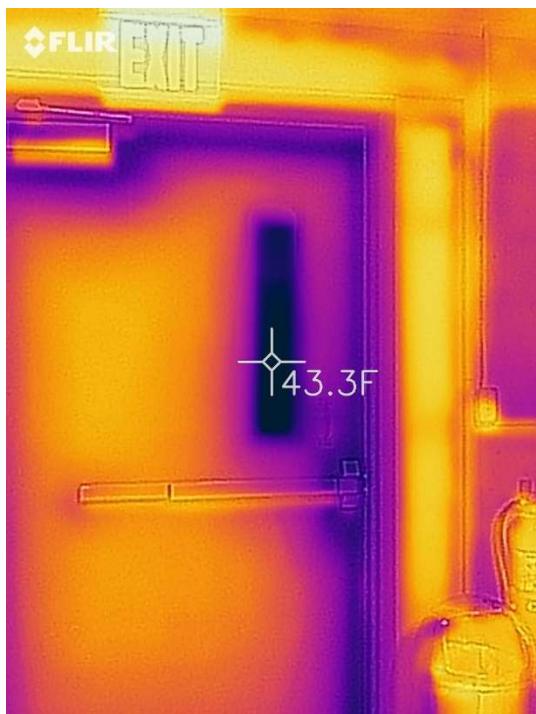
Figure 9-Foyer Door

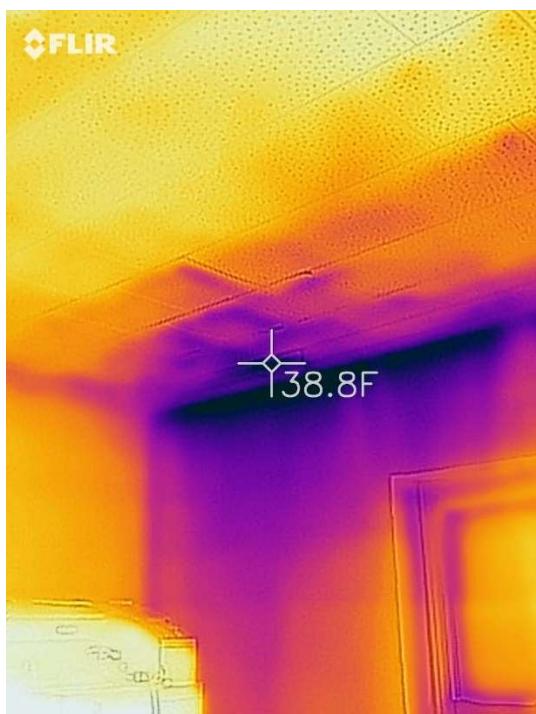
Figure 10-Children's Storage Room Ceiling

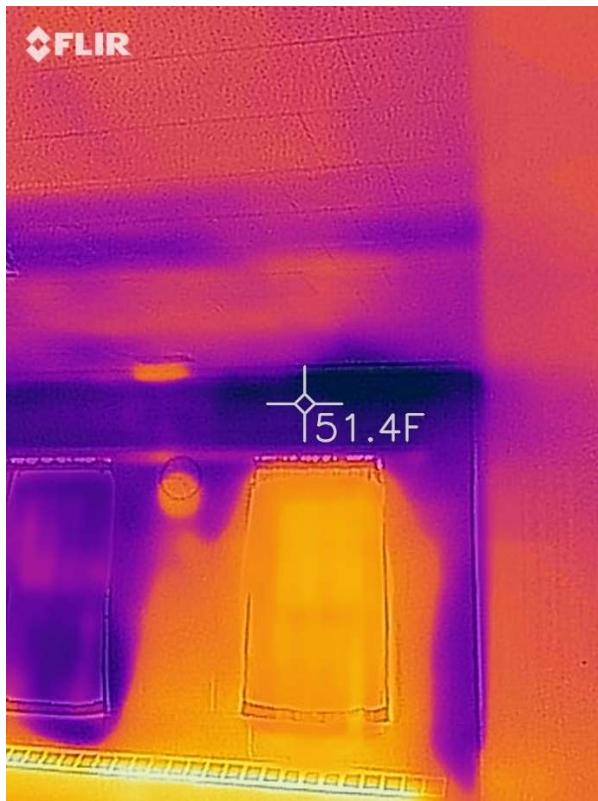
Figure 11-Classroom Closet to Children's Bathroom

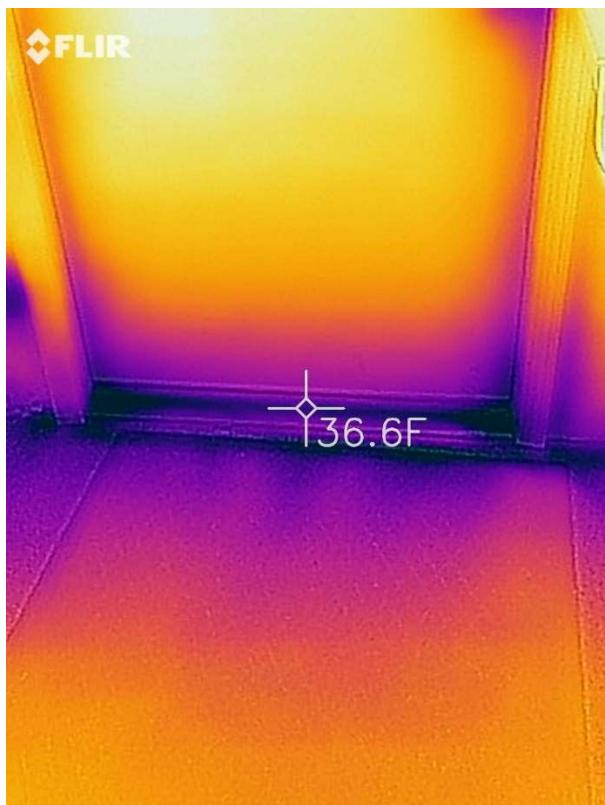
The middle exterior door leading to the janitor's closet seals well except at the bottom, and the door handle and deadbolt provide quite a bit of thermal conduction. The bottom of the door should be sealed. (Figure 12-Breezeway Exterior Door Bottom)

Figure 12-Breezeway Exterior Door Bottom

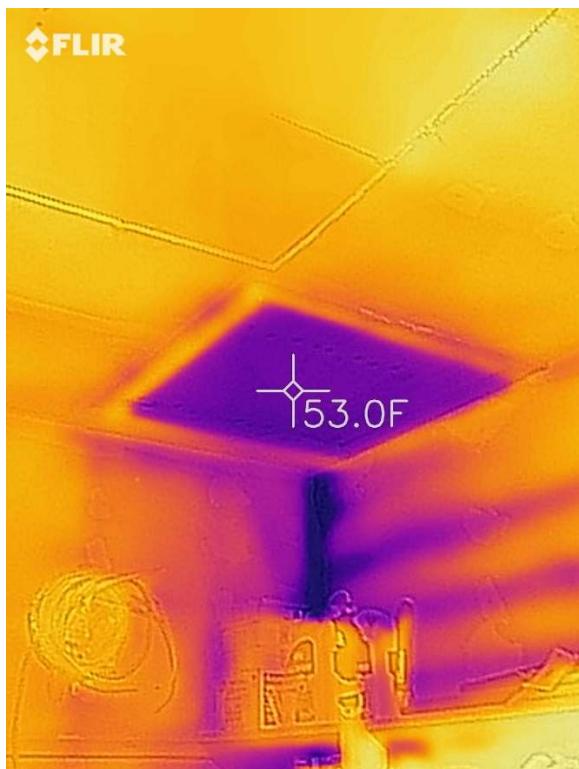
Figure 13-Janitor's Closet Attic Access Point

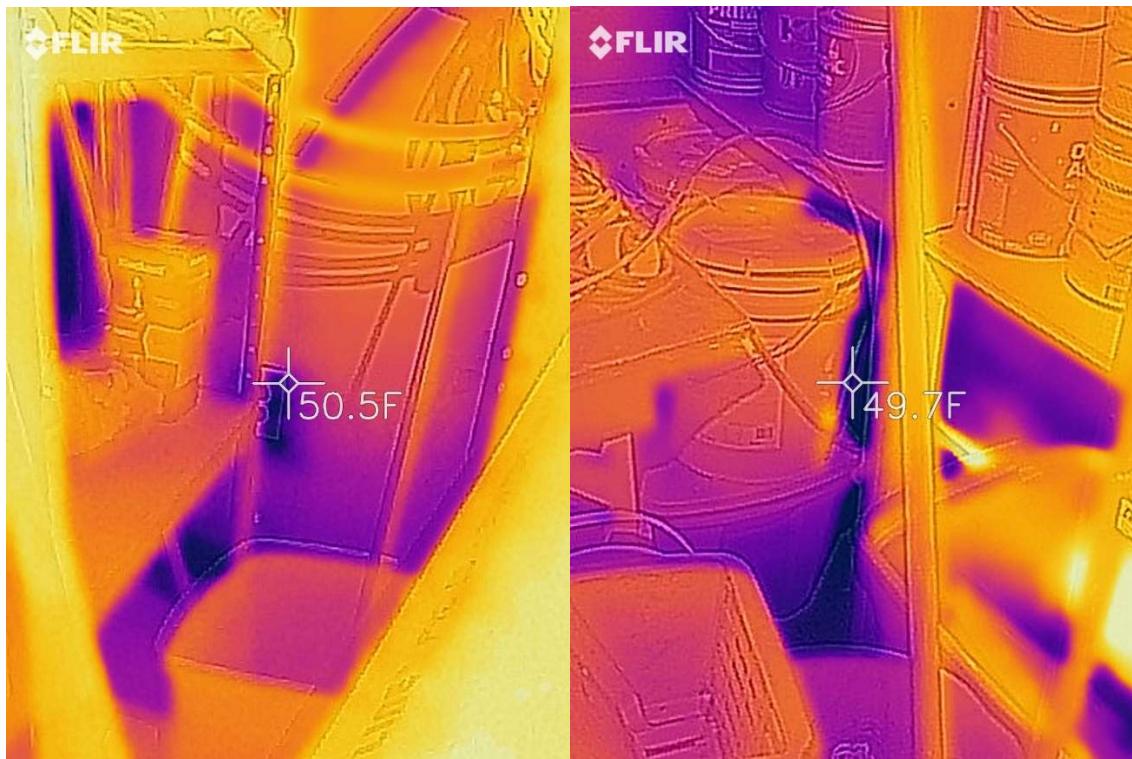
The janitor's closet is well insulated except the two power outlets on the East wall, and the attic access point. Recommend insulation around the outlets, and on the access panel. There is moderate wind at the janitor's closet light switch, however the switch is the same 67°F temperature as the surrounding surfaces. (Figure 14-Janitor's Closet Outlets)

Figure 14-Janitor's Closet Outlets

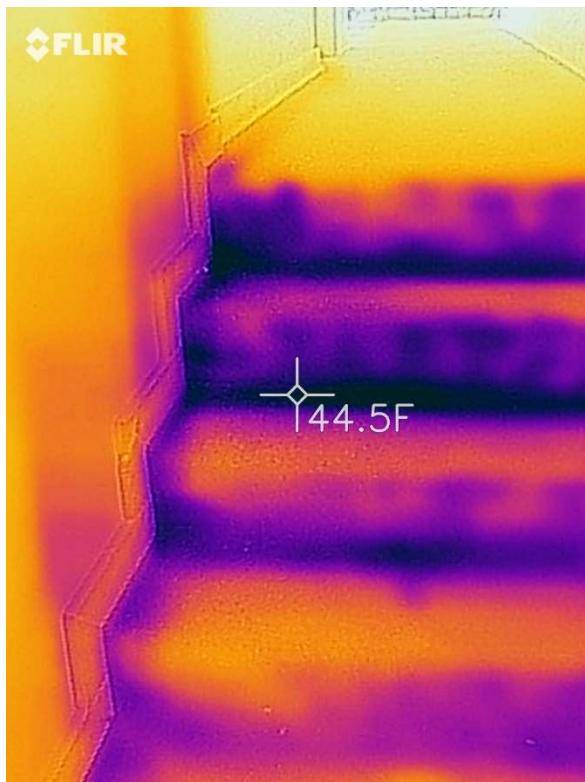
The stairs to the Fellowship Hall are moderate heat loss points, and should be insulated from the trailer crawl space. (Figure 15-Breezeway Stairs to Fellowship Hall)

Figure 15-Breezeway Stairs to Fellowship Hall

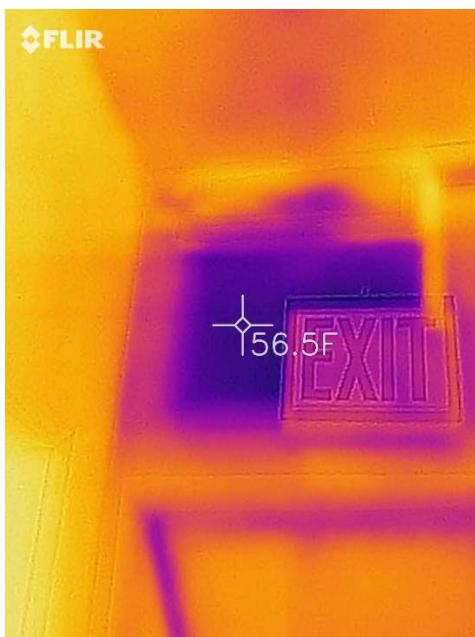
The wall above the stairs leading to the Breezeway and Children's Area appears to be an old window which has been sheet-rocked over (Figure 16-Wall Above Fellowship Hall Stairs). This is a moderate energy-loss point, especially for heat. Recommend insulating this wall and replacing the cardboard above the window. The cardboard is not a significant energy loss point.

Figure 16-Wall Above Fellowship Hall Stairs

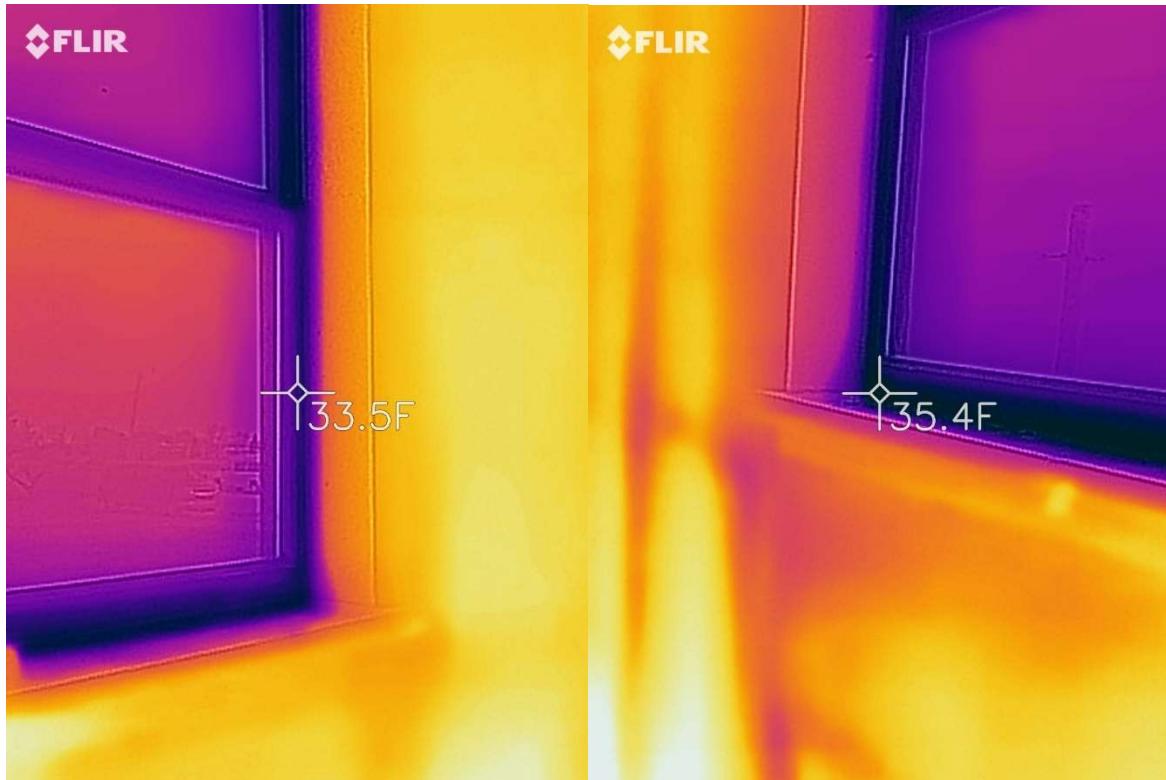
The windows in the fellowship hall are extreme energy loss points. Recommend replacing windows or installing curtains or blinds. (Figure 17-Two Fellowship Hall Windows, typical of all Fellowship Hall windows)

Figure 17-Two Fellowship Hall Windows, typical of all Fellowship Hall windows

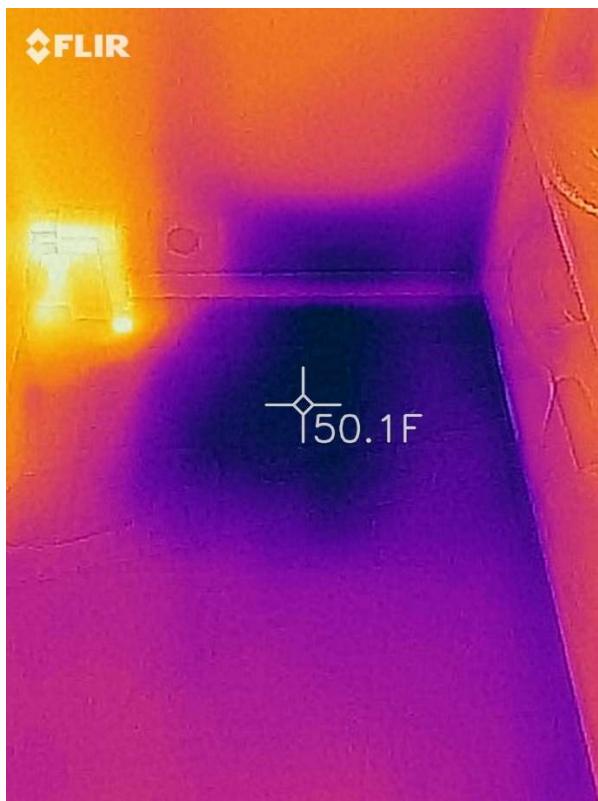
The floor in the kitchen is substantially colder than the walls. (Figure 18-Kitchen Floor Near Oven Outlet)

Figure 18-Kitchen Floor Near Oven Outlet

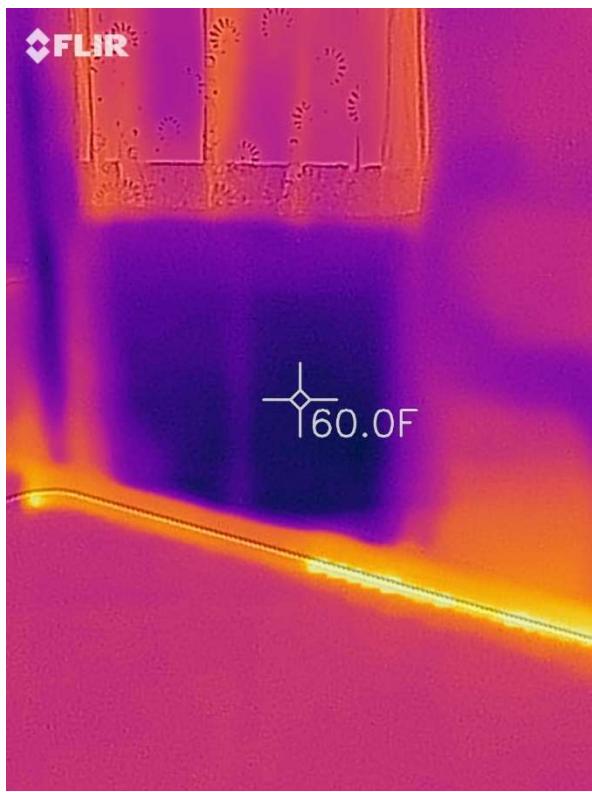
The wall under the North East window has inadequate insulation and/or the baseboard heat is not radiating in this area. (Figure 19-North East Window Wall Insulation)

Figure 19-North East Window Wall Insulation

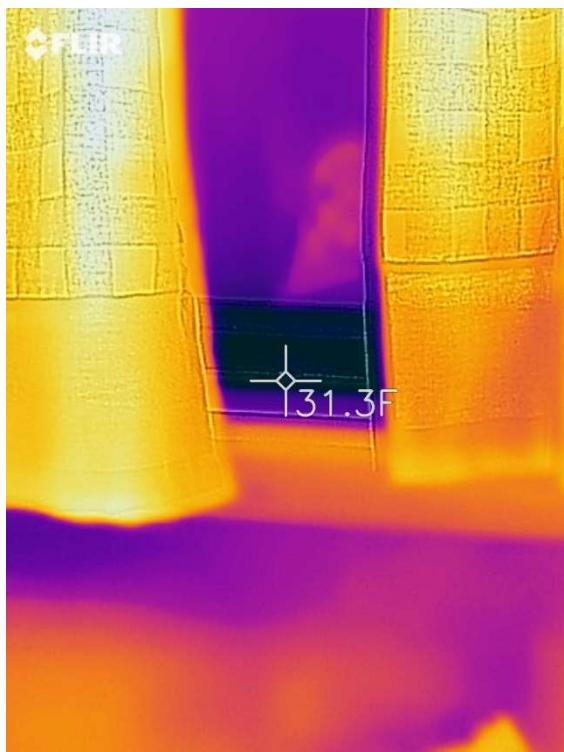
The North window is an extreme energy loss point. (Figure 20-North Window)

Figure 20-North Window

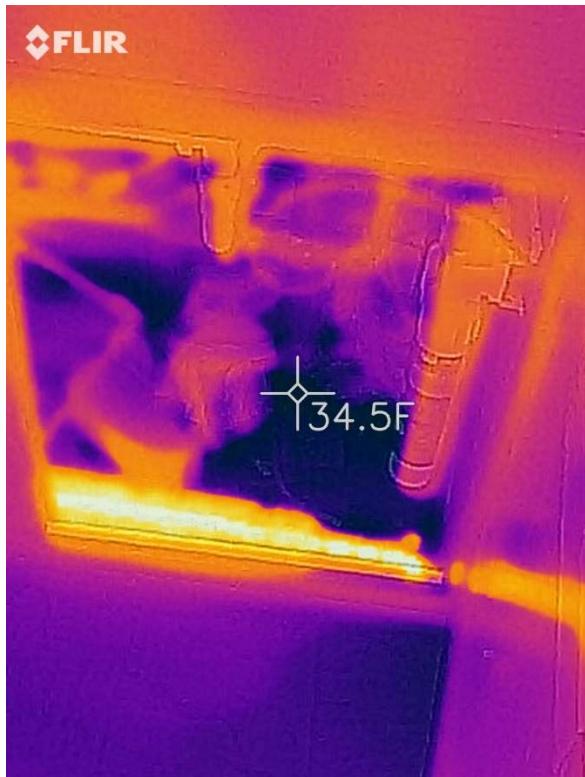
The undersink area, despite having a boiler heat radiator, is extremely cold and in danger of freezing. (Figure 21-Undersink)

Figure 21-Undersink

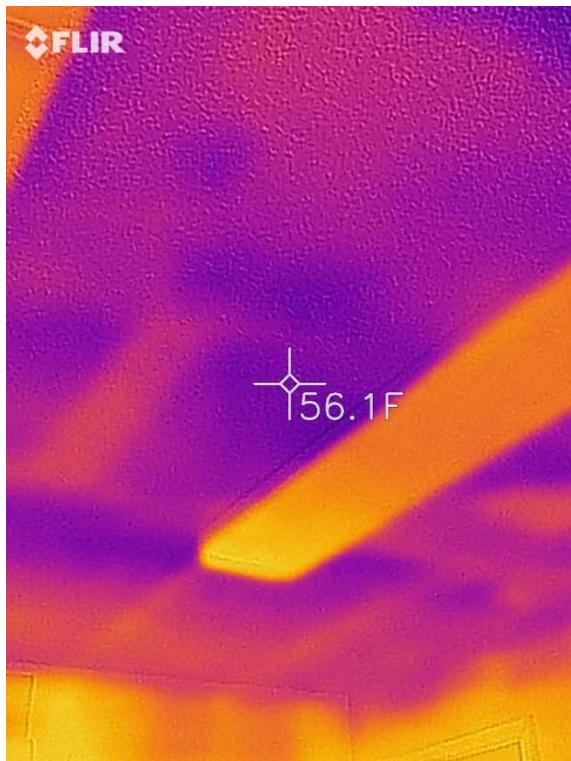
The ceiling is inadequately insulated. (Figure 22-Kitchen Ceiling – Warm Rectangle is the Neon Light)

Figure 22-Kitchen Ceiling – Warm Rectangle is the Neon Light

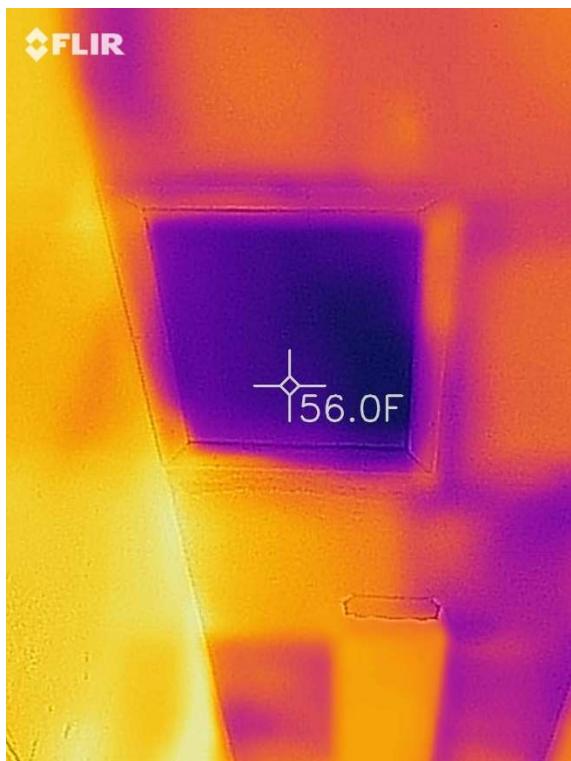
The primary energy loss points are the North wall and Attic Access. (Figure 23-Shower/Bathroom Attic Access, Figure 24-North Wall-Hall, Figure 25-North Wall - Bathroom)

Figure 23-Shower/Bathroom Attic Access

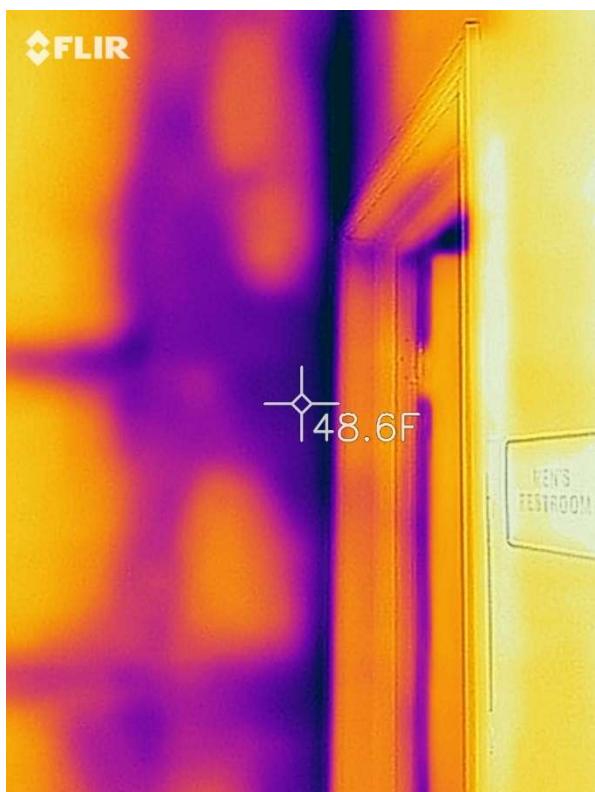
Figure 24-North Wall-Hall

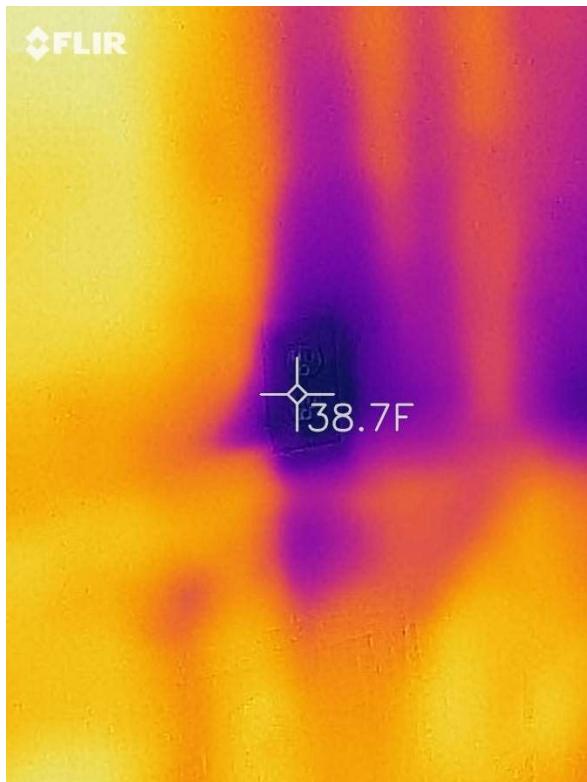
Figure 25-North Wall - Bathroom
