# 200 W 4th St Inspection Report

**200 W 4th St**

## Commercial Inspection 06062022

Inspection of School at 200 West 4<sup>th</sup> St, Brady, Texas

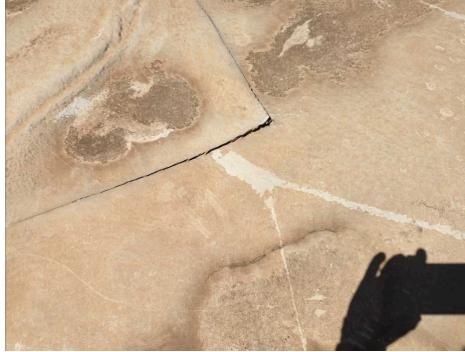
Foam deterioration by old flue

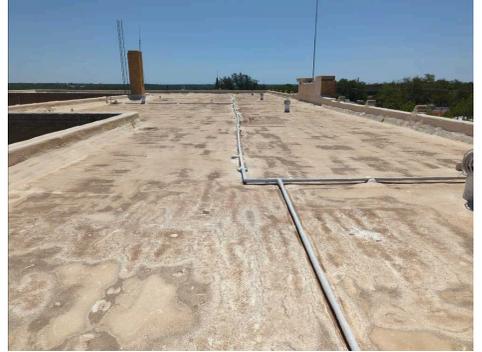
Roof covering is in poor condition. Ponding across roof, areas where top coat has deteriorated and coming loose. Also unprofessional patches and segments coming apart. Expect this roof will begin to leak soon if not already.

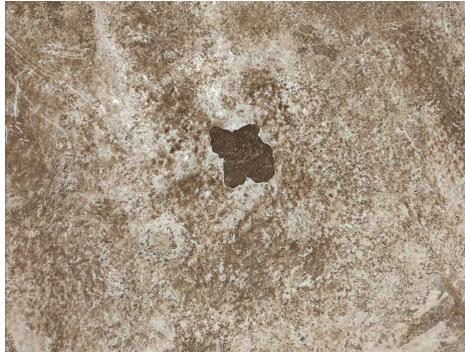
Some roof covering is loose and gives when walked on

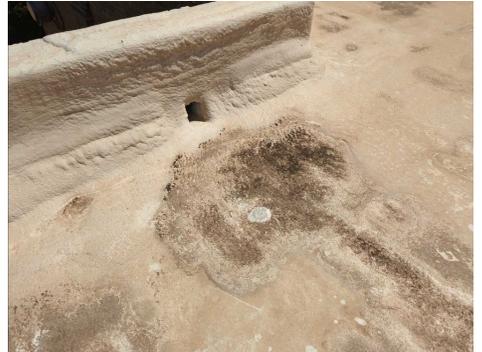
Roof covering is in poor condition. Ponding across roof, areas where top coat has deteriorated and coming loose. Also unprofessional patches and segments coming apart. Expect this roof will begin to leak soon if not already.

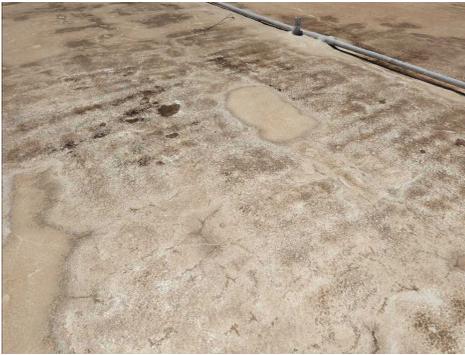
Roof covering is in poor condition. Ponding across roof, areas where top coat has deteriorated and coming loose. Also unprofessional patches and segments coming apart. Expect this roof will begin to leak soon if not already.

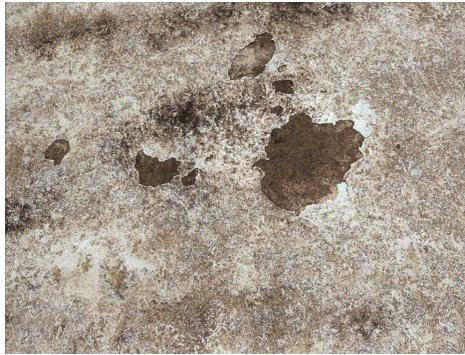
Roof covering is in poor condition. Ponding across roof, areas where top coat has deteriorated and coming loose. Also unprofessional patches and segments coming apart. Expect this roof will begin to leak soon if not already.

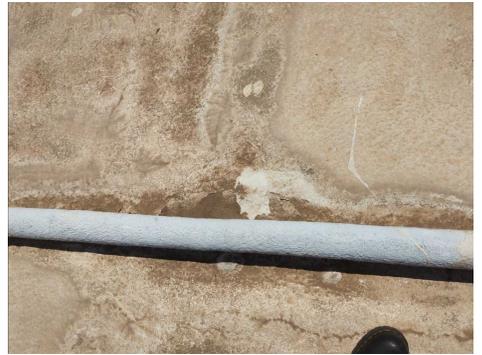
Roof covering is in poor condition. Ponding across roof, areas where top coat has deteriorated and coming loose. Also unprofessional patches and segments coming apart. Expect this roof will begin to leak soon if not already.

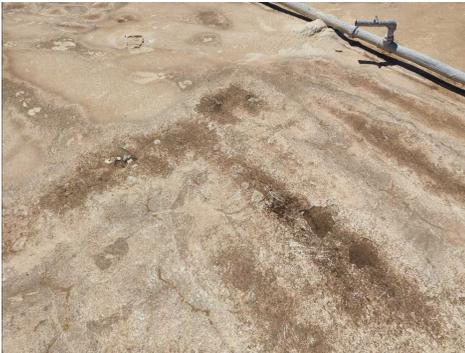
Roof covering is in poor condition. Ponding across roof, areas where top coat has deteriorated and coming loose. Also unprofessional patches and segments coming apart. Expect this roof will begin to leak soon if not already.

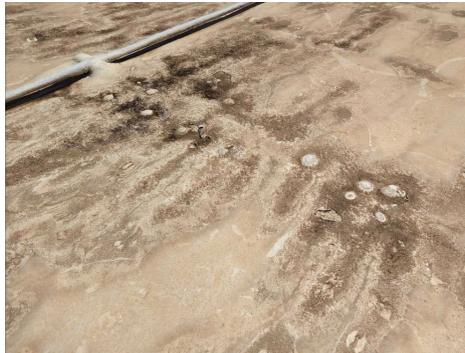
Roof covering is in poor condition. Ponding across roof, areas where top coat has deteriorated and coming loose. Also unprofessional patches and segments coming apart. Expect this roof will begin to leak soon if not already.

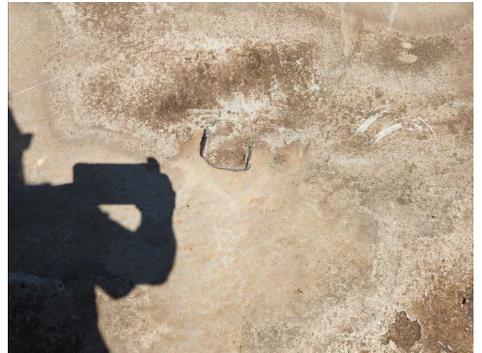
Roof covering is in poor condition. Ponding across roof, areas where top coat has deteriorated and coming loose. Also unprofessional patches and segments coming apart. Expect this roof will begin to leak soon if not already.

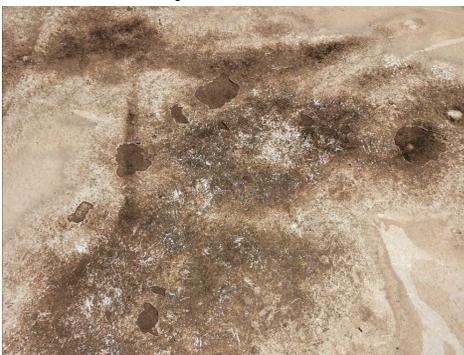
Roof covering is in poor condition. Ponding across roof, areas where top coat has deteriorated and coming loose. Also unprofessional patches and segments coming apart. Expect this roof will begin to leak soon if not already.

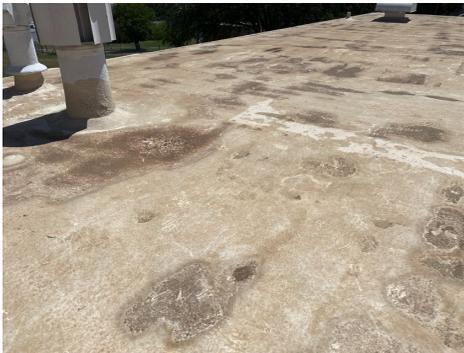
Ponding is evident on several areas across the roof of the roof. Recommend contacting a licensed roofing contractor to review repair options.

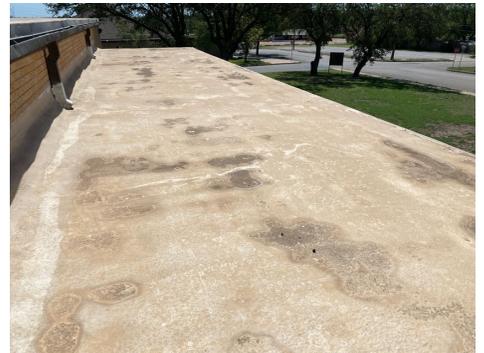
Ponding is evident on several areas across the roof of the roof. Recommend contacting a licensed roofing contractor to review repair options.

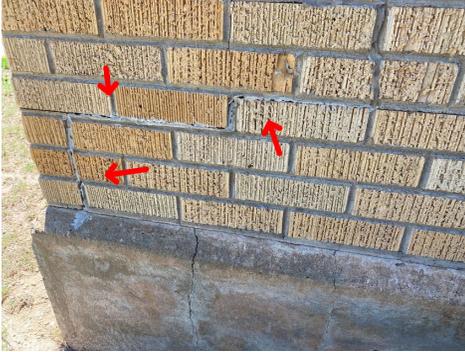
One or more cracks in exterior masonry, stucco or grout.. Front right corner of structure

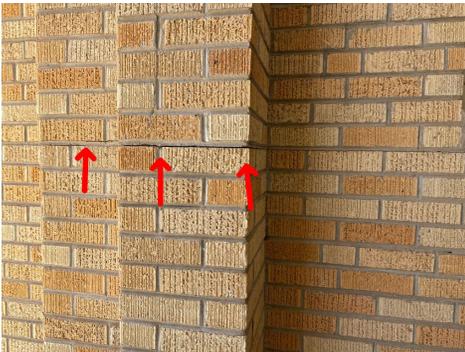
One or more cracks in exterior masonry, stucco or grout. Recommend repair or repoint by mason. On left side of main entrance

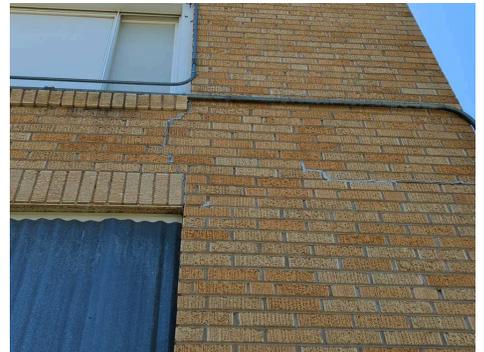
One or more cracks in exterior masonry, stucco or grout. Recommend repair or repoint by mason. Back

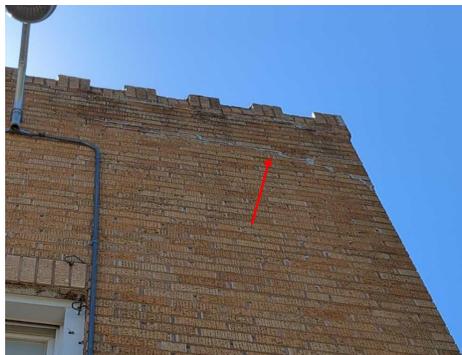
One or more cracks in exterior masonry, stucco or grout. Recommend repair or repoint by mason. Back

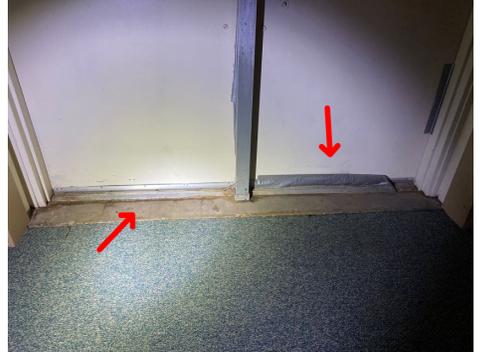
Exit door on sanctuary is missing threshold and weatherstripping.

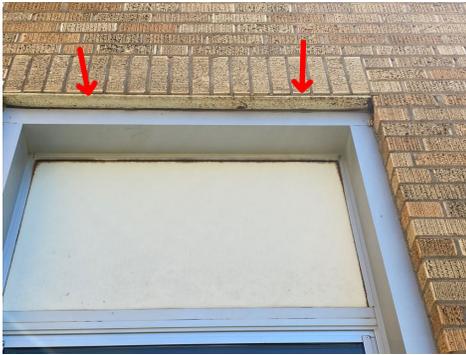
Rusted lintels on all windows. Recommend painting.

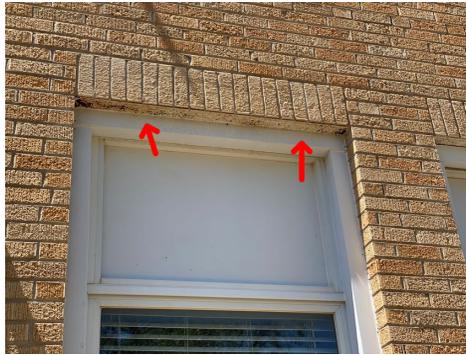
Rusted lintels on all windows. Recommend painting.

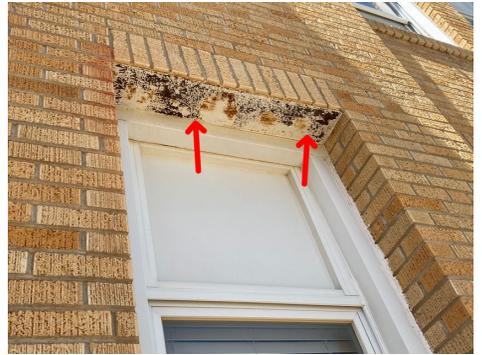
Rusted lintels on all windows. Recommend painting.

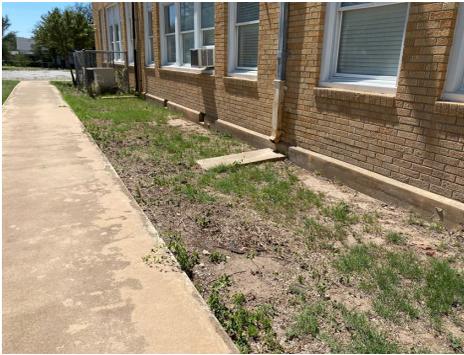
It was observed that the current drainage was directed towards the building and should slope away from the foundation a minimum of {6"} in a {10'} span

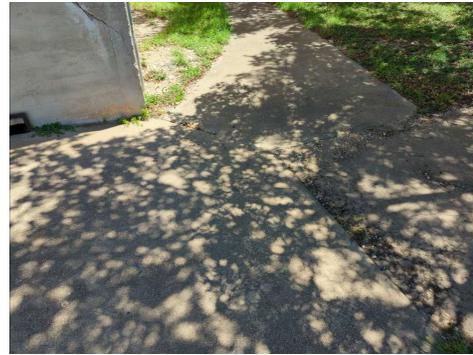
Grading in back ponds by foundation. Recommend drainage be installed to move water away from building

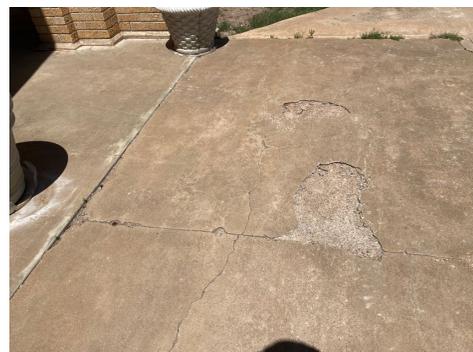
Cracks on sidewalk. In front of main entrance

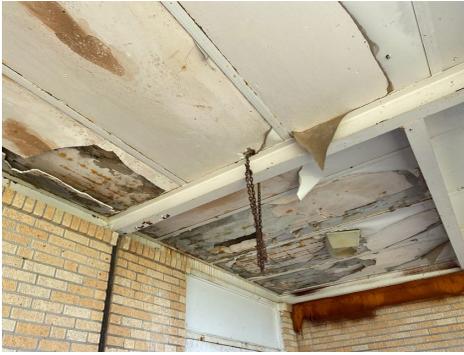
Awning in back has water deterioration and damage. Recommend repair

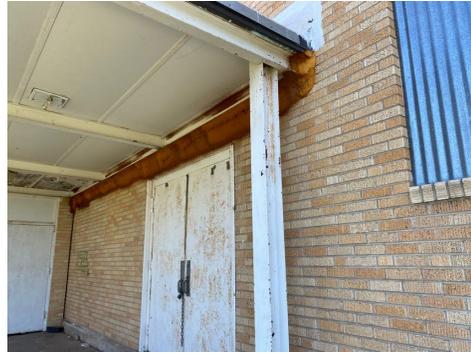
Awning in back has water deterioration and damage. Recommend repair

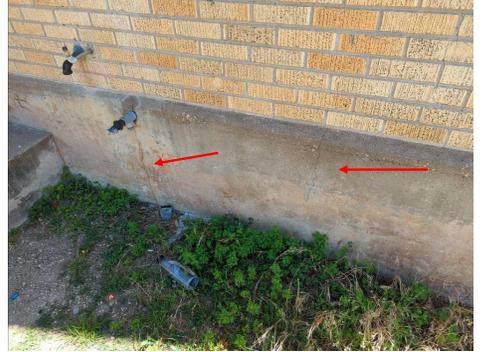
Cracking found in foundation in several areas. Back

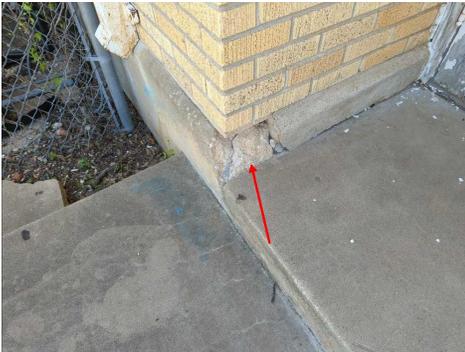
Cracking found in foundation in several areas. Back

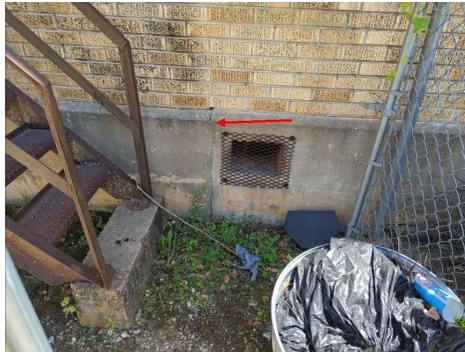
Cracking found in foundation in several areas. Back

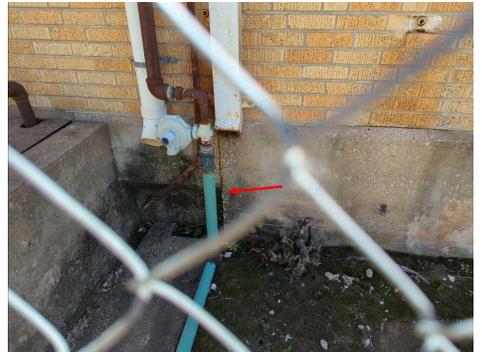
Cracking found in foundation in several areas. Back

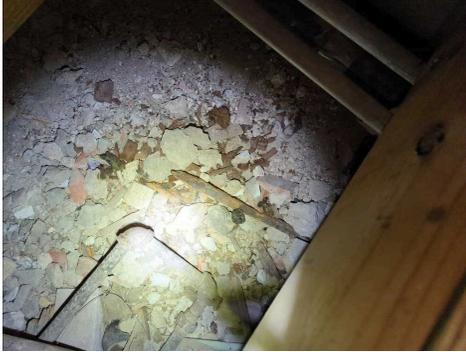
Animals are in crawlspaces - droppings present

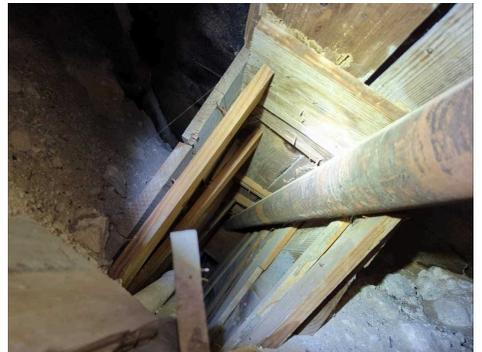
Crawlspace supports. Recommend pier and beam be evaluated for improvement. Uneven and slopes present. In this case improper boards in contact with earth and used as a pier

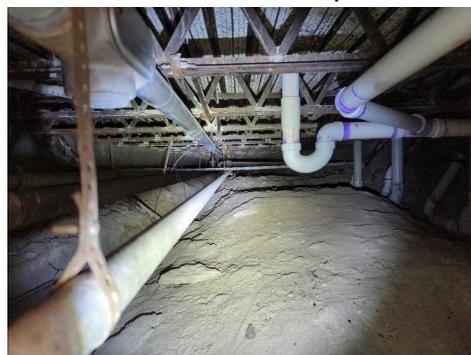
Crawlspace view...limited piers found

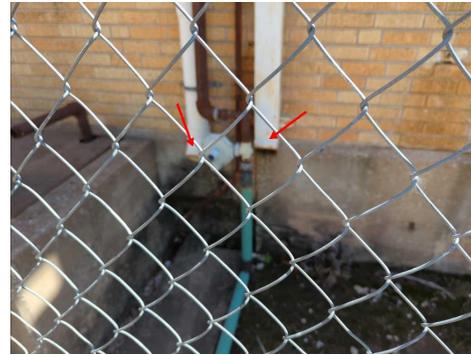
Downspouts are emptying roof water next to basement. Recommend these be extended past this area

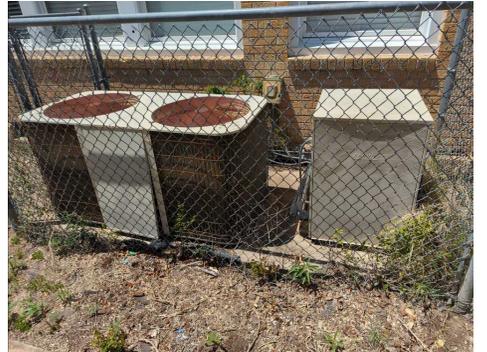
One or more exterior HVAC systems past useful life

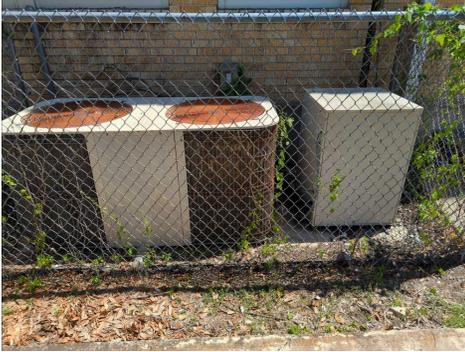
One or more exterior HVAC systems past useful life

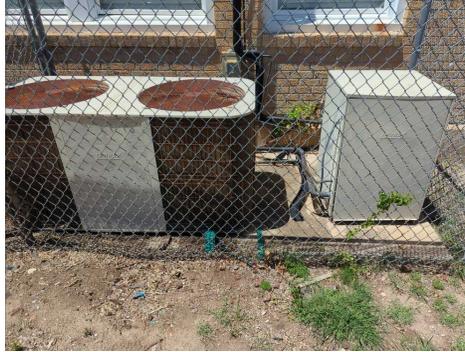
One or more exterior HVAC systems are past useful life with deficiencies in freon line insulation, electrical wiring coming loose and a hazard and corrosion

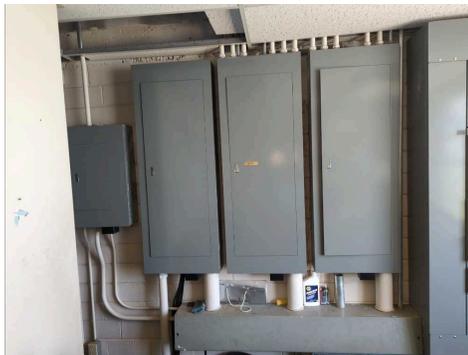
Electrical panel and shut off are installed incorrectly and need correction by licensed electrician. Safety hazards  
 Right wing of building

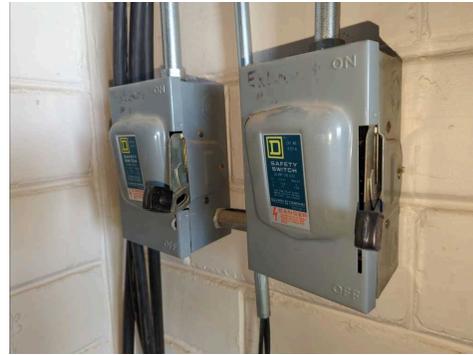
One or more fused shut off switches will not shut and are a safety hazard. Behind Stage

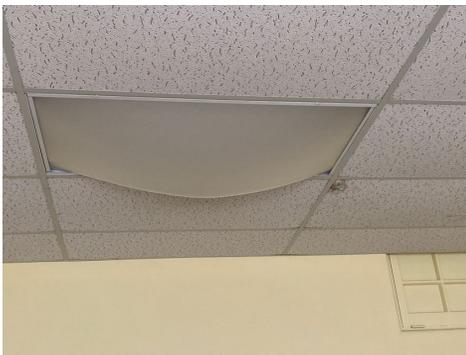
Light cover needs repair. Front right classroom

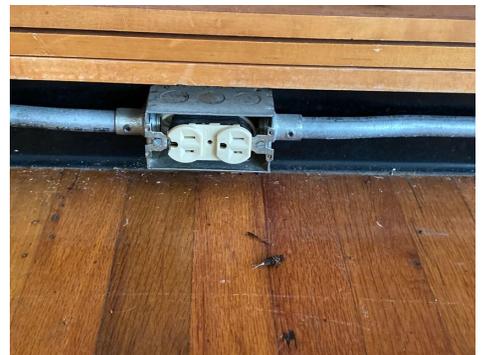
One or more electrical outlets missing covers. Recommend electrician evaluate. Room #100

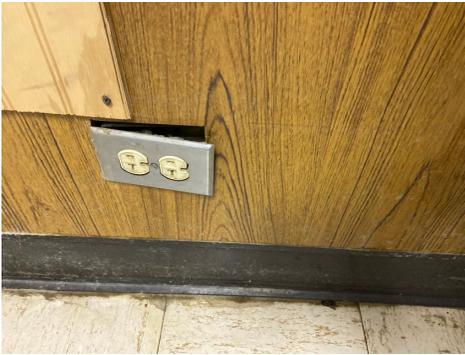
One or more electrical outlets loose or missing covers. Recommend electrician evaluate. Upstairs hallway

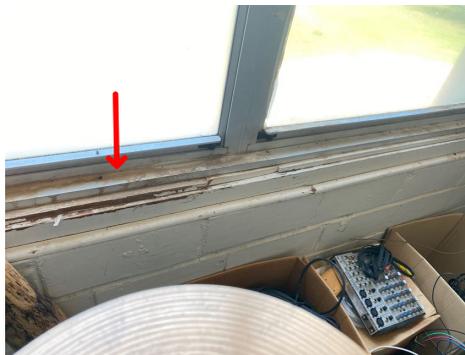
Wood window frames need repair in one or more areas.

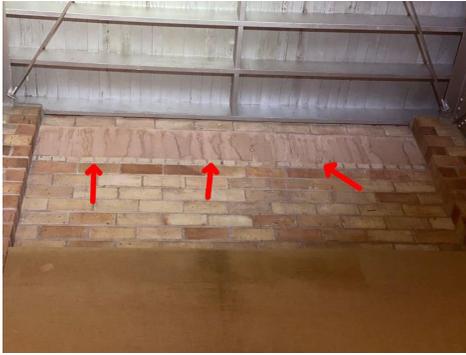
Water stains on wall coming from roof parapet. Along sanctuary wall

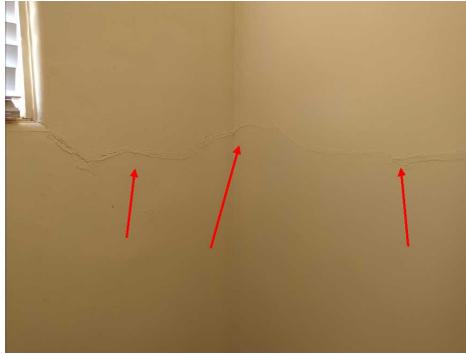
Horizontal cracking on bathroom. Front side downstairs

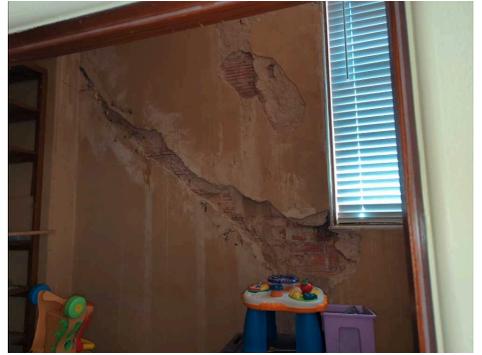
Cracks on right side of building.

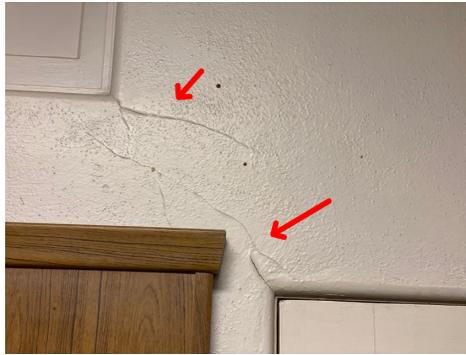
Cracking on one or more walls. Right upstairs room

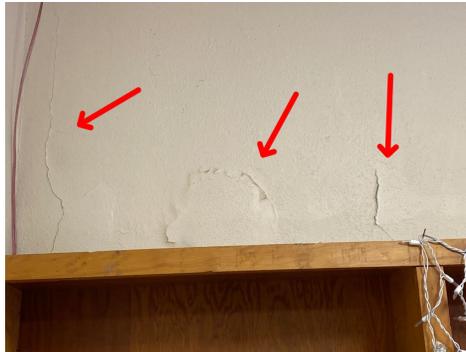
Cracks on right side of building. Upstairs

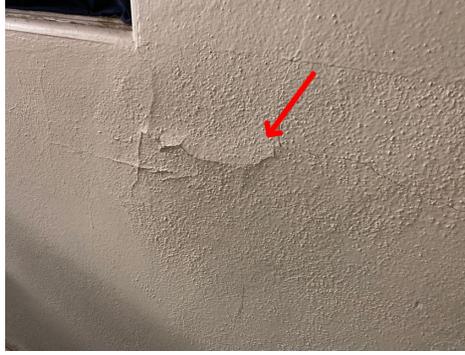
Cracking on one or more walls. Upstairs right room on wall with windows.

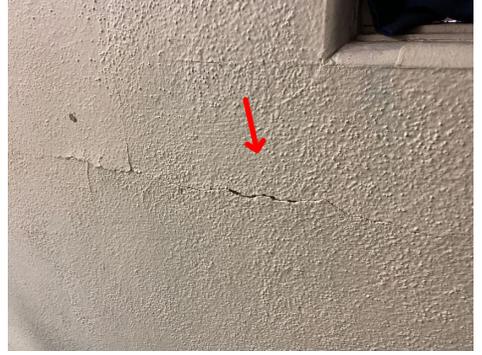
Cracking on one or more walls. Upstairs right room on wall with windows.

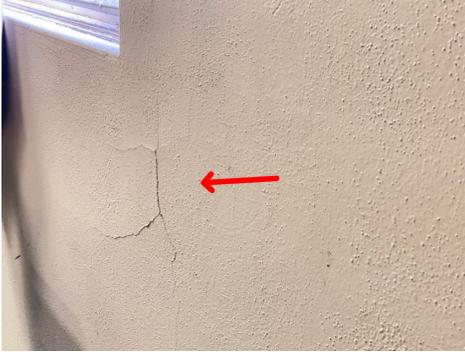
Cracking on one or more walls. Upstairs right room on wall with windows.

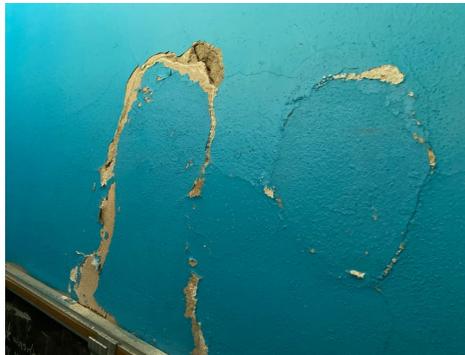
Cracking on one or more walls. Upstairs classroom 200

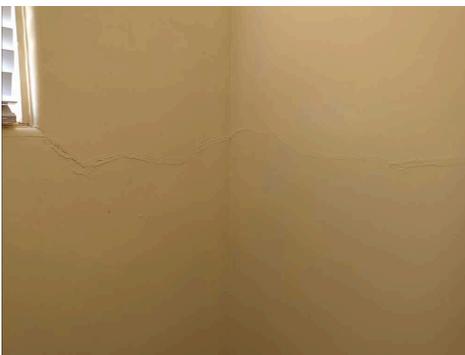
Horizontal cracking on bathroom. Front side downstairs

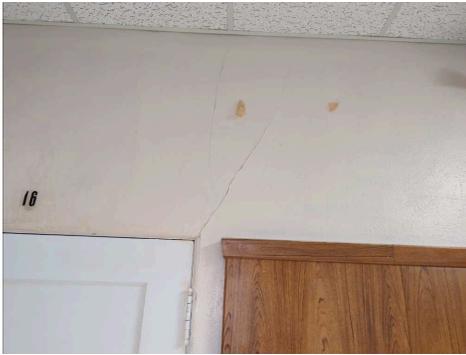
Cracks in interior walls on second floor. This is in hallway

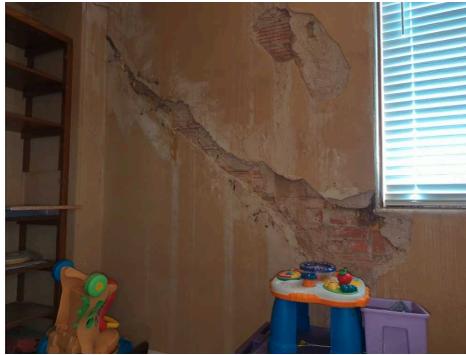
One or more cracks on right side front.

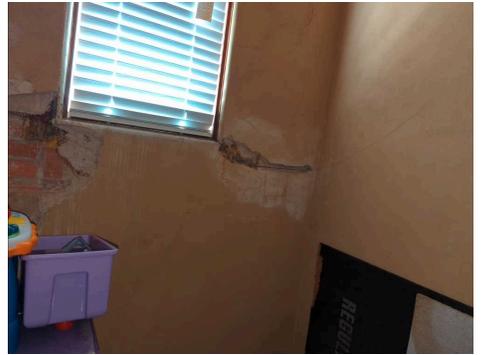
One or more cracks on right side front.

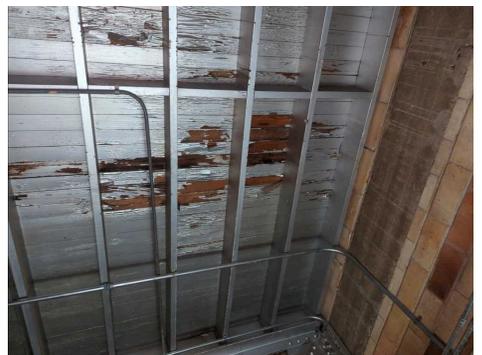
Ceiling in one or more areas have water stains. Some deterioration also. Above backstage

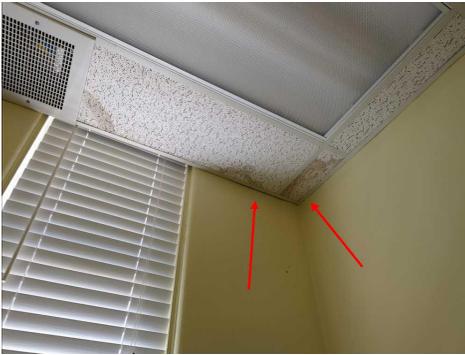
Water stains on ceiling front right bathroom downstairs

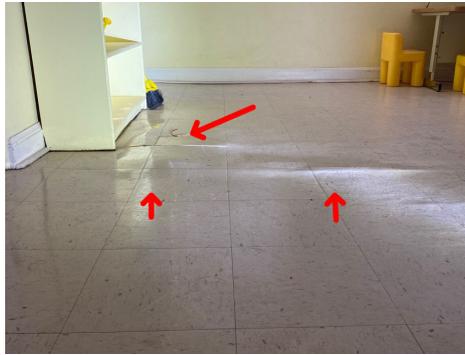
Uneven floors in front right classroom

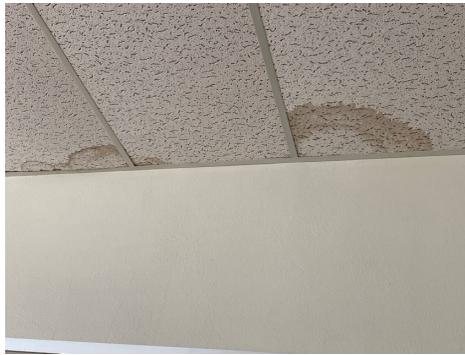
Ceiling tiles have water stains on one or more areas. Room 100

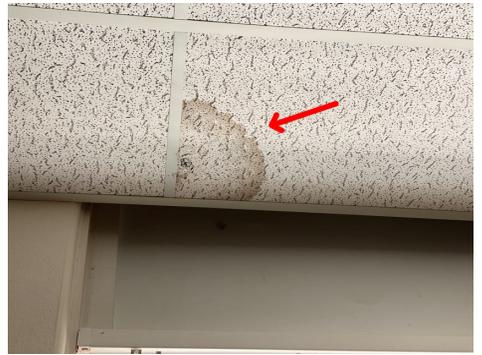
Ceiling tiles have water stains on one or more areas. Room 100

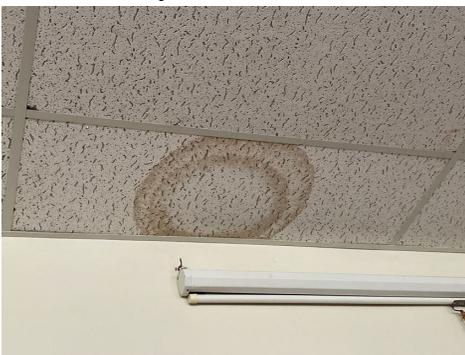
Ceiling tiles have water stains on one or more areas. 102

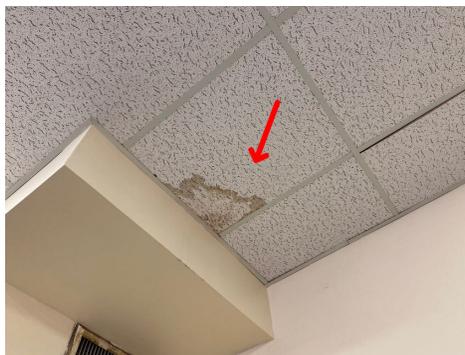
Ceiling tiles have water stains on one or more areas. Upstairs far right room

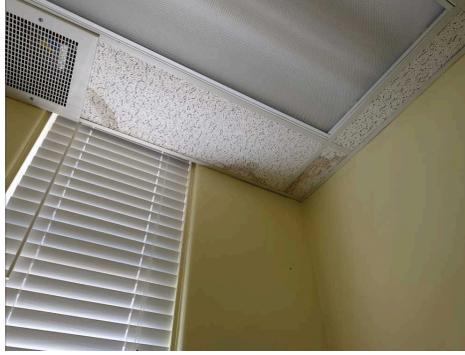
Water stains on ceiling front right bathroom downstairs

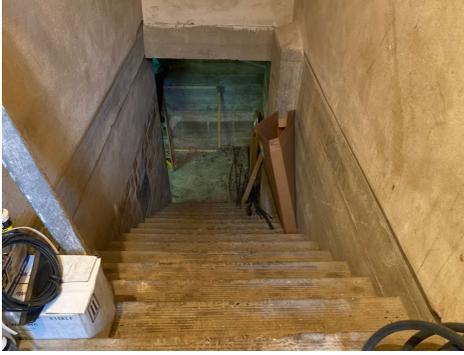
Recommend handrails on stairs leading down to basement.

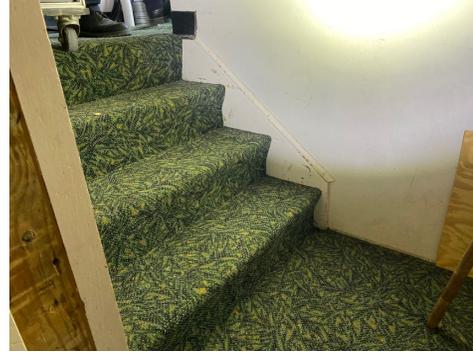
Stairs in sanctuary needs handrail on at least one side.
