L. M. Swayze Engineers, PLLC

July 1, 2022

Re: Site Visit to 200 West 4th Street,
Brady, Texas

Purpose of Visit: Visual Observation of Existing
School Building, circa 1942, to
Try to Determine Condition of
Existing Structure

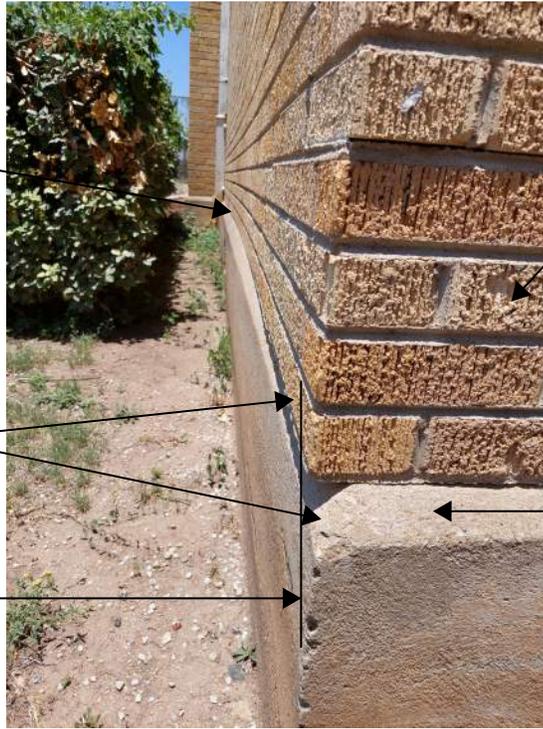
The masonry veneer is constructed with common brick with a vertical striation pattern on each masonry unit. It is laid in a common Flemish bond pattern. No expansion joints are present in the veneer. This has caused the veneer on the south side of the building to move horizontally at least 1 1/2 inches at the west end and a smaller amount at the east end. The west side veneer at the southwest corner and the southside veneer at that same corner, have moved enough horizontally such that the west and south faces of the veneer are flush with the vertical face of the concrete beam on each side of that corner. Refer to photos on Page 6.

The corners of the foundation present the worst visible foundation damage on the structure. The damage seems to have been caused by horizontal movement of the masonry veneer due to expansion from solar heating, because no expansion joints in the veneer were installed initially.

Notice how the masonry veneer has moved back to the original position @ the edge of the 1 1/2" chamfer, as you look down the face of the wall to the north .

Masonry veneer has moved to the west and is now flush with the 1 1/2" chamfer of top of foundation beam.

Face of veneer and foundation beam.

4. New 3/8" thick masonry expansion joints with backer rod and the appropriate caulking compound, should be cut into the exterior veneer to facilitate reworking the masonry at the corners of the long building and ease the expansion stresses in the veneer. The joints should be approximately 20 feet on center or at the upper and lower corners of the sets of multiple windows on the long faces of the building.

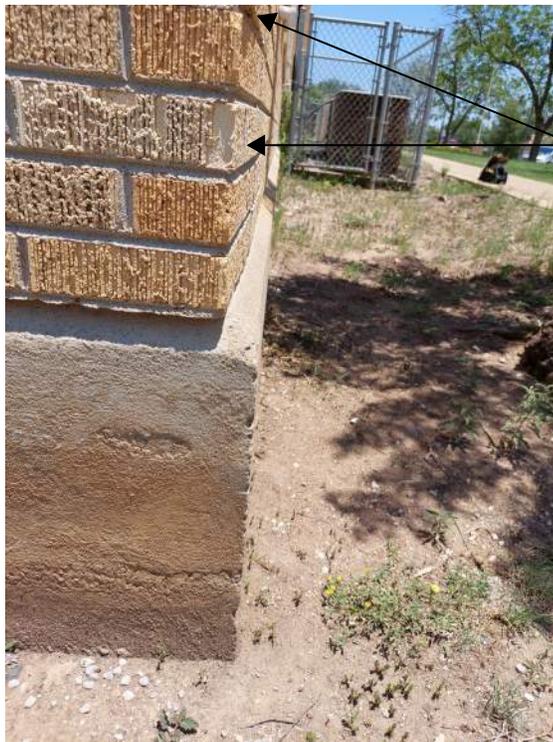
Southwest corner looking north

Masonry veneer above the 4th course has moved to the south and now protrudes outward approx. 1/2" while the bottom 4 courses remain in their original position @ top of 1 1/2" chamfer.

1 1/2" chamfer of top of foundation beam.

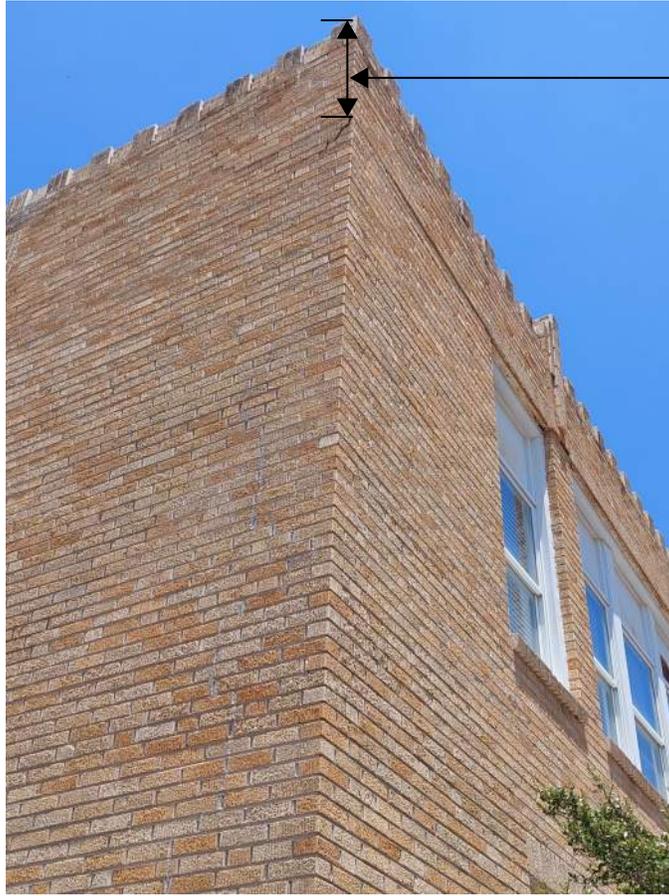
Southwest corner looking east

Masonry veneer above the 4th course has moved to the south and now protrudes outward approx. 1/2" while the bottom 4 courses remain in their original position @ top of 1 1/2" chamfer.

Masonry veneer band at the parapet level has moved to the south and and to the west and now protrudes outward approx. 1/2", while the bottom veneer panel on each side of the corner behaves as described on Page 6.

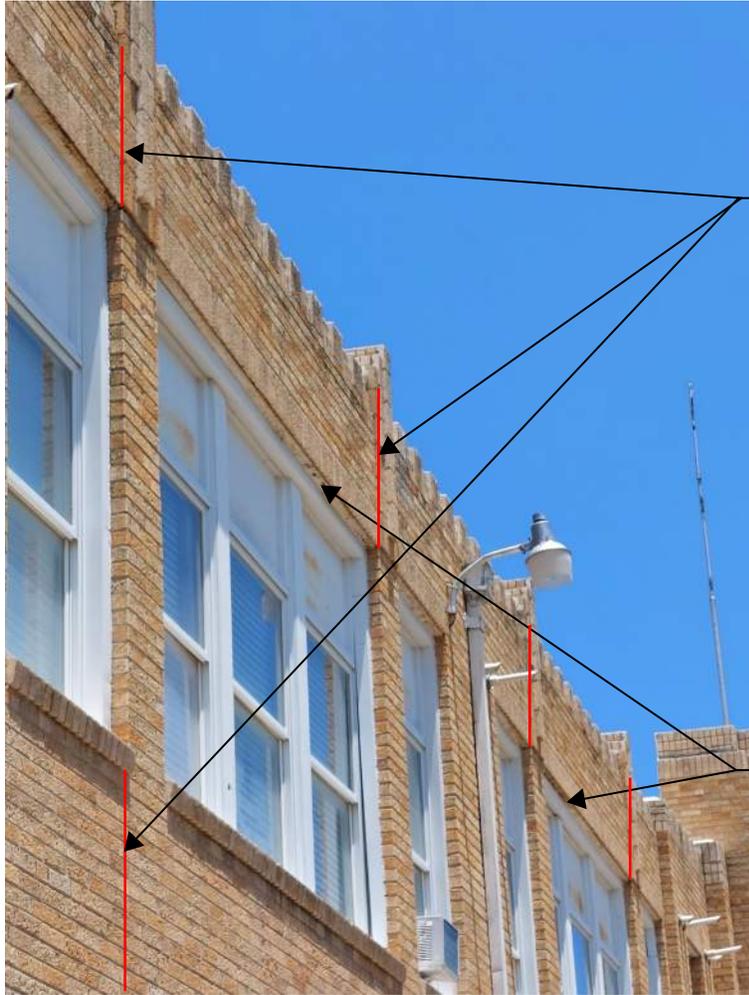
Southwest corner looking northeast

Masonry veneer band at the parapet level.

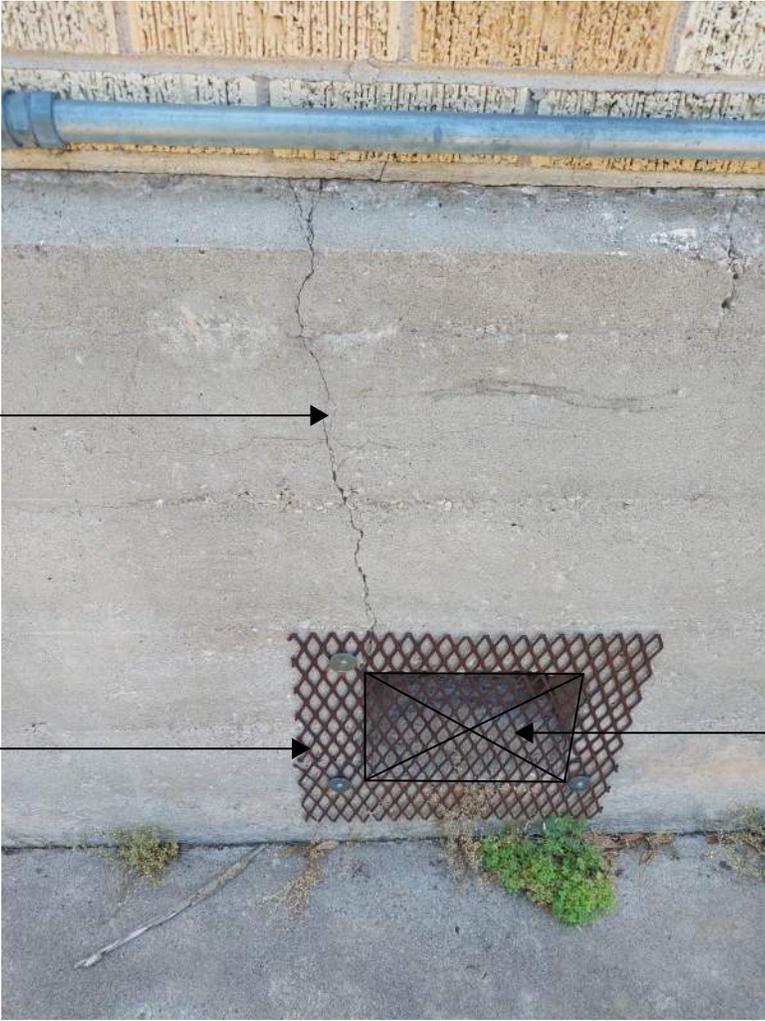
Typical Underfloor Foundation Vent

The foundation is suspended above the ground surface with 12 inch by 12 inch air vents present on the north and south sides of the building. Those vents are covered with expanded steel mesh in most cases. Therefore, access to the underfloor system from the exterior is limited and viewing the floor framing system is difficult at best. Refer to photo on Page 9.

Numerous expansion cracks and settlement cracks were noted on all sides of the foundation. Small cracks were also noted at the upper re-entrant corners of the previously mention foundation vents. Refer to photos on Pages 9 and 10.

Typical crack @ re-entrant corner of foundation vent.

Typical expanded metal on all foundation vents.

Typical foundation vent opening.

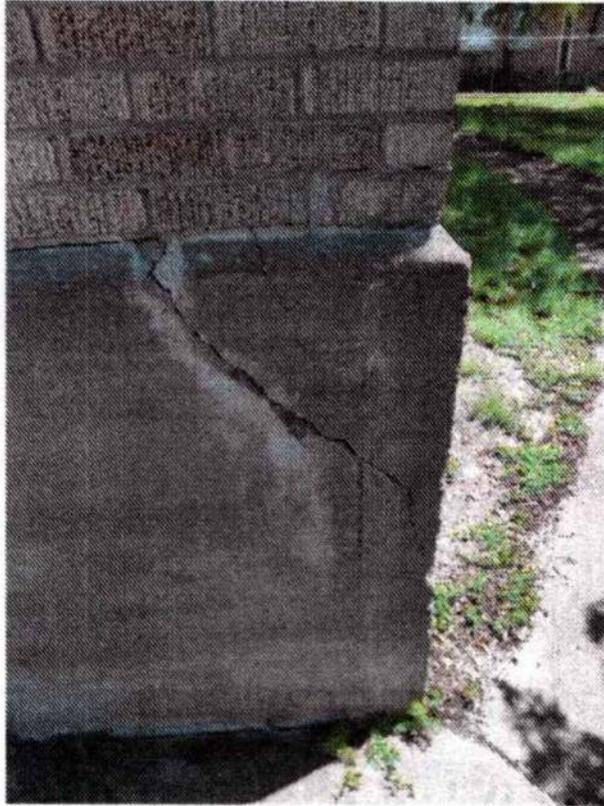
Typical Foundation Cracking Condition at Corners
Caused by Movement of Masonry Veneer Where
Veneer Bonded to Masonry Lug @ Foundation

For instance, at the southeast corner, pouring a new diagonal concrete beam supported by a drilled pier on each end, below the existing concrete foundation beam (to avoid the existing corner footing) would arrest any further settlement.
