# Centennial UMC Congregational Meeting

November 3, 2024

# Roseville Roof Project Status

# Background for the RV roof

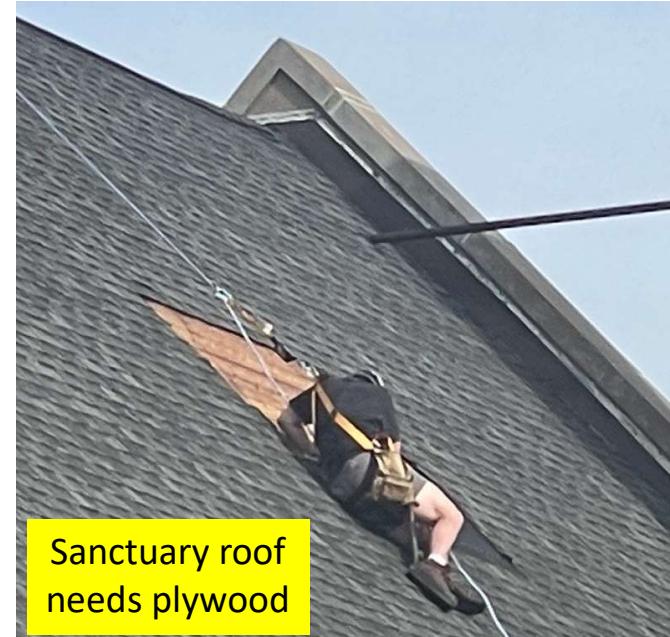
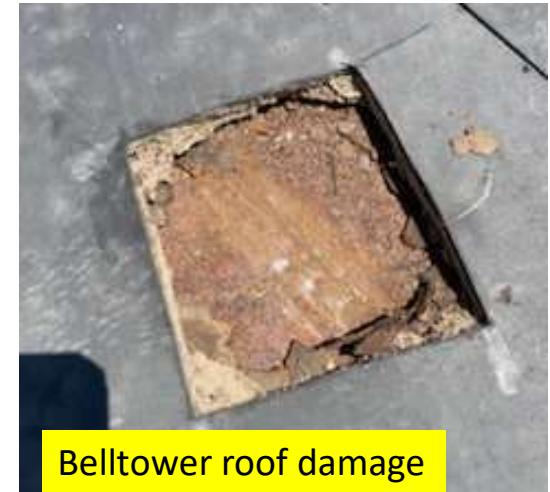
- Aug 2020: hail storm damaged roof (building closed for Covid)
- Dec 2021: signed agreement with contractor
- 2022: worked with insurance company → denied claim
- Late 2022: filed lawsuit to preserve claim rights
- 2023 – May 2024: repeated attempts at mediation
- May 2024: mediation session held, but unsuccessful
- Summer 2024: gathered 2020 pricing bids; did invasive tests
- Oct 21, 2024: insurance company agreed to appraisal process
- Appraisal panel scheduling in progress
- Late fall 2024: start roof work?

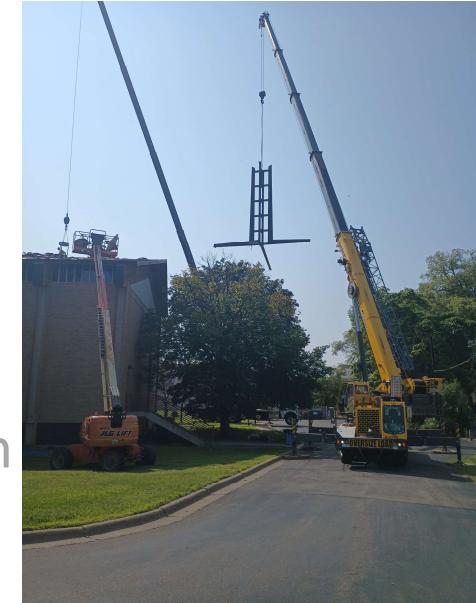
- May 2022: wind storm damaged roof
- 2023: worked with insurance
- Nov 2023: replaced all shingles; discovered extra damage on sanctuary roof; covered with temporary patch
- Nov '23 – Apr '24: previous contractor delays progress
- May 2024: filed lawsuit to preserve claim option past 2-year limit
- Summer 2024: engineering study
- Aug 19, 2024: removed steeple & cross; installed temporary roof
- Fall 2024: contractors settle on final design for repair
- Spring 2025: Install new ceiling/roof boards and finish roof

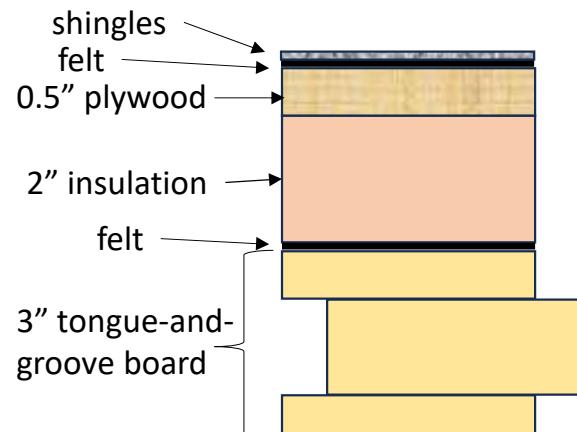
*Roof cross-section*

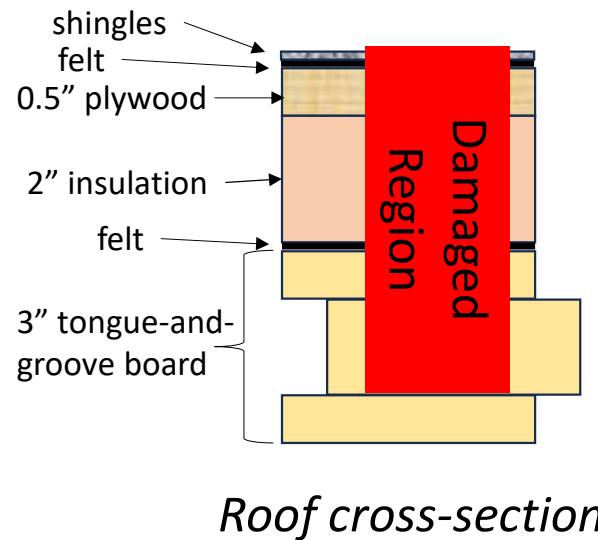
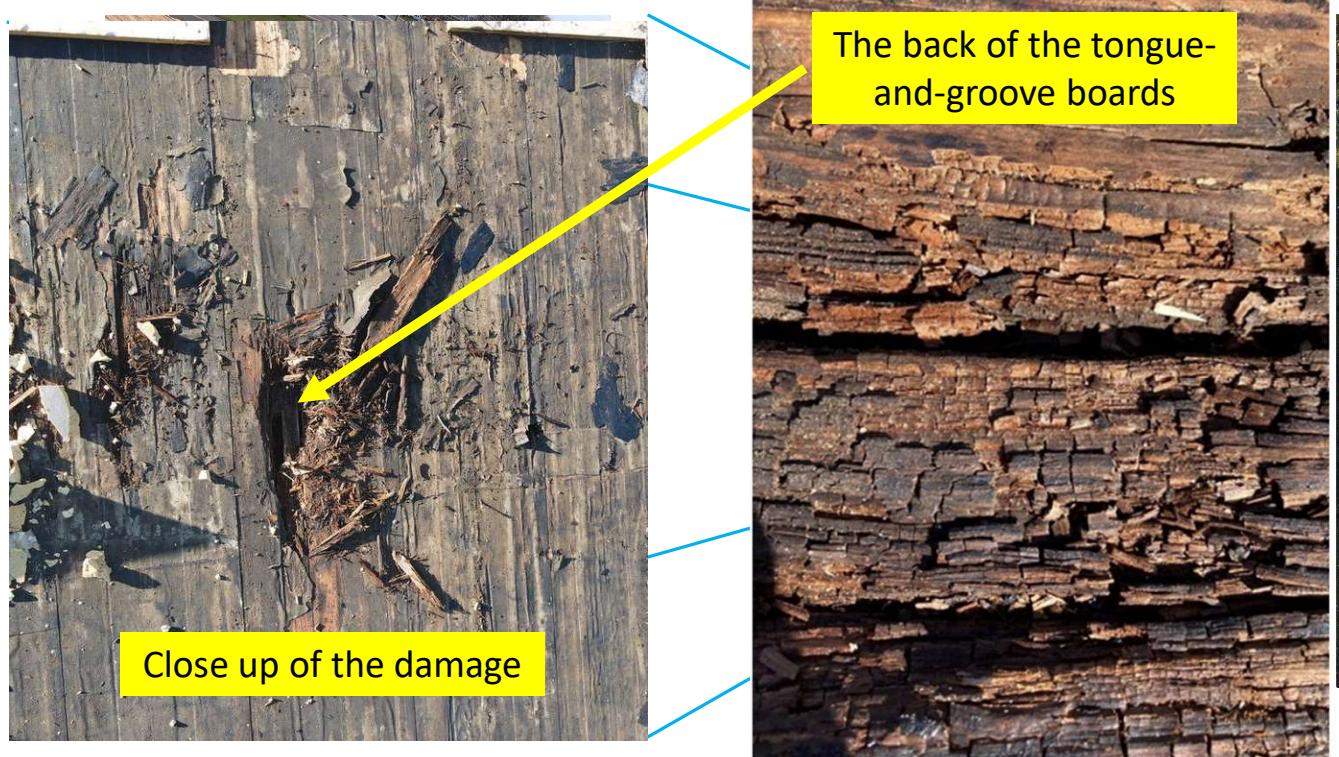
- Damage to the north side of the roof is much worse than it appears from inside the sanctuary

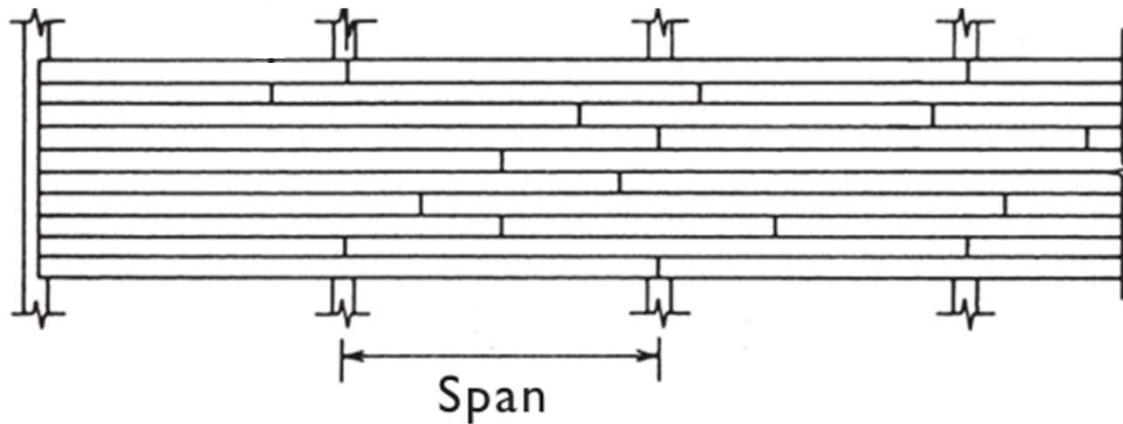
# Roof board pattern: strengths and weaknesses

- Boards are assembled with random end locations (to distribute the weak points) to make a single, strong piece
- Boards are nailed together, so can't replace some without damaging others

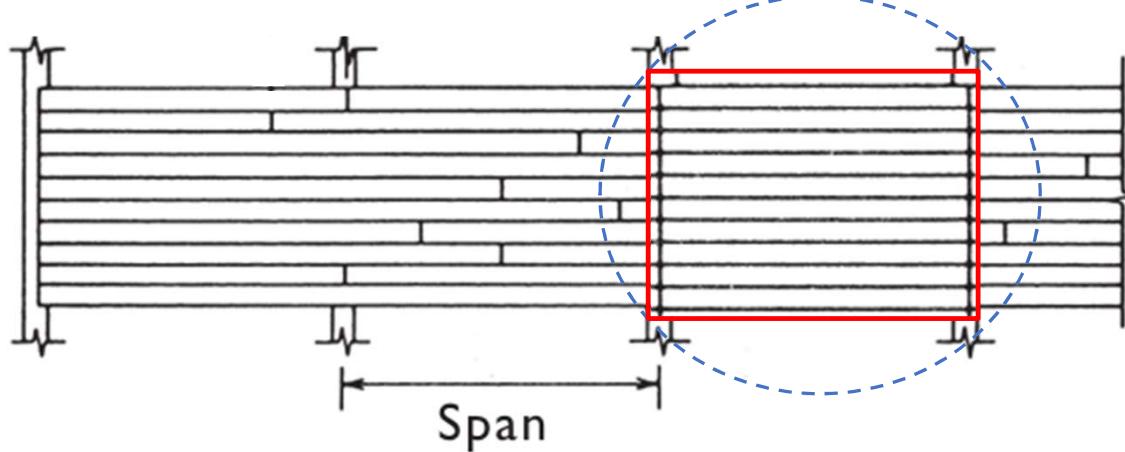
# Roof board pattern: strengths and weaknesses

- Boards are assembled with random end locations (to distribute the weak points) to make a single, strong piece
- Boards are nailed together, so can't replace some without damaging others
- Not possible to replace a section and have same strength

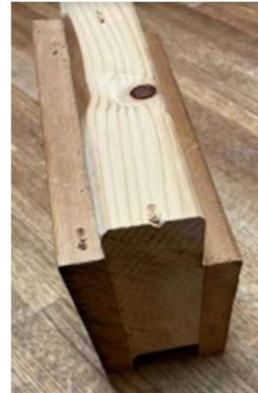
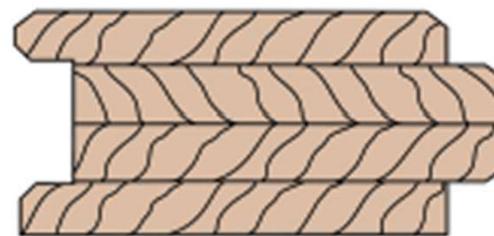
**Old boards:** 3 layers of wood/2 layers of adhesive

**New boards:** 4 layers of wood/3 layers of adhesive

- Existing roof has been grandfathered under old code
- If we fix the structural problems on one side of the roof, then the entire side of the roof must be replaced to bring it up to code.
- The south half is not subject to this requirement
- New boards are same size as old boards, but stronger:
