# 200 W 4th St Inspection Report

**200 W 4th St**

## Commercial Inspection 06062022

Inspection of School at 200 West 4<sup>th</sup> St, Brady, Texas

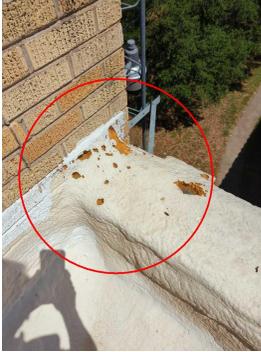
Foam deterioration by old flue

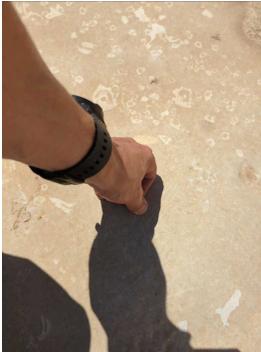
Some roof covering is loose and gives when walked on

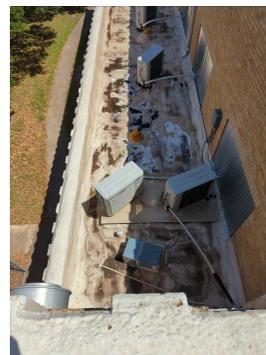
Left side of sanctuary short roof in poor condition

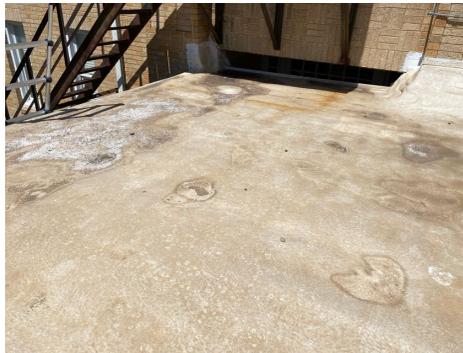
Ponding is evident on several areas across the roof of the roof. Recommend contacting a licensed roofing contractor to review repair options.

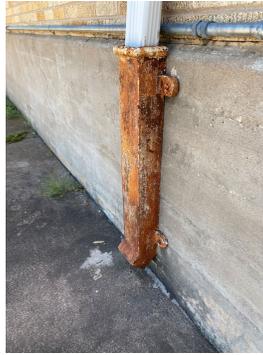
Downspouts around perimeter of building need to be repaired

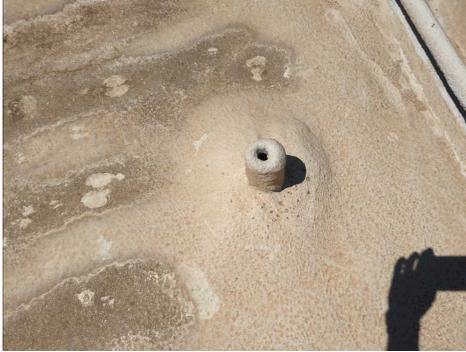
Roof foam has reduced plumbing vents beyond plumbing guidelines and needs to be cleaned out.

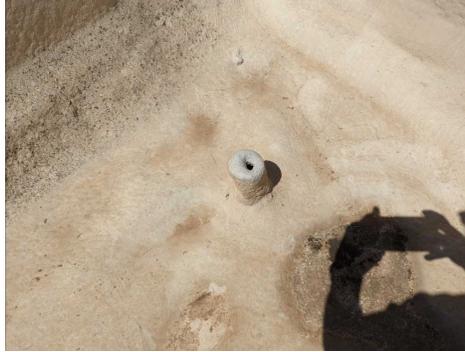
Roof foam has reduced plumbing vents beyond plumbing guidelines and needs to be cleaned out.

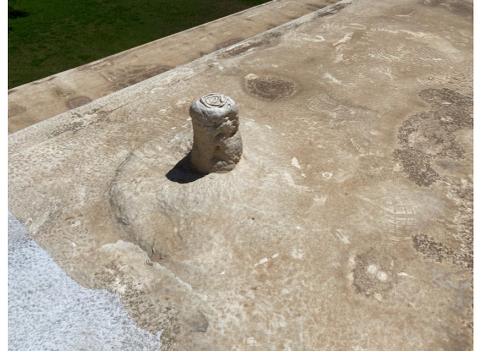
One or more plumbing vents on roof are covered with roofing material.

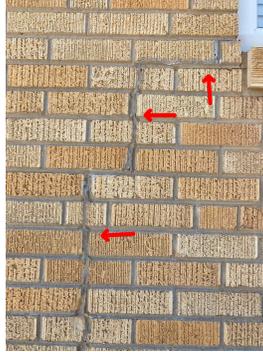
One or more cracks in exterior masonry, stucco or grout. Front right corner of structure

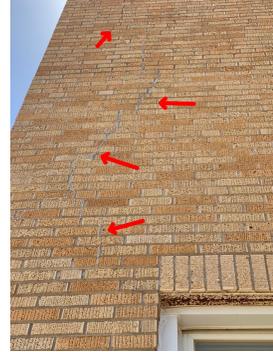
One or more cracks in exterior masonry, stucco or grout. Front right corner of structure

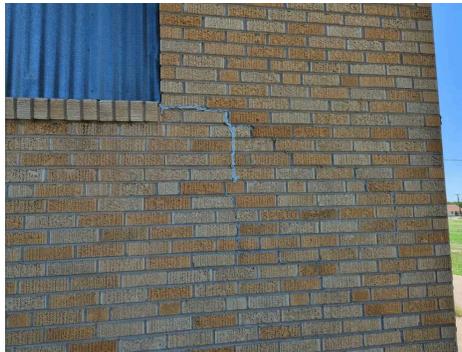
One or more cracks in exterior masonry, stucco or grout. Recommend repair or repoint by mason. Back

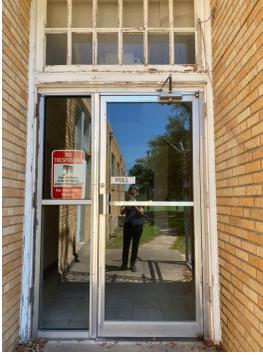
Back door has water damage on wood trim that frames windows and doors

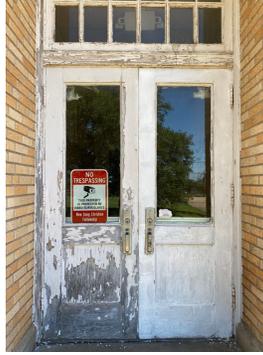
Both sets of backdoors have water damage on wood trim that frames windows and doors

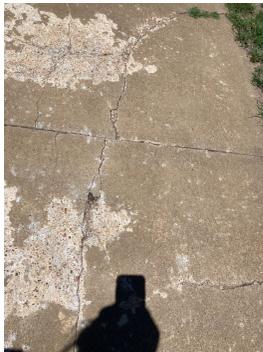
Cracks on sidewalk

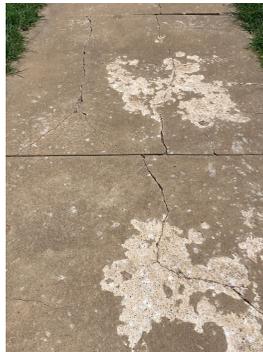
Cracks on sidewalk

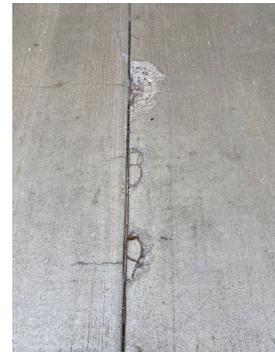
Cracks on sidewalk causing trip hazard. Recommend monitor. Outside sanctuary

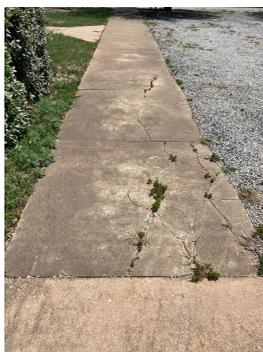
Cracks on sidewalk. On far left of building.

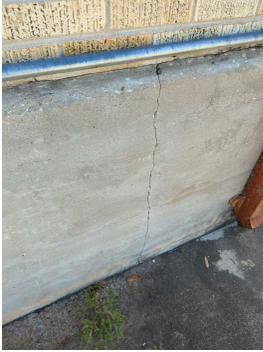
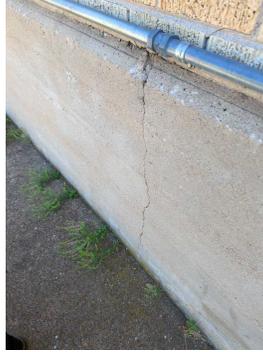
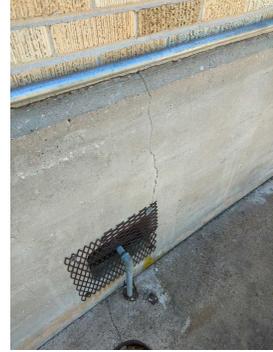
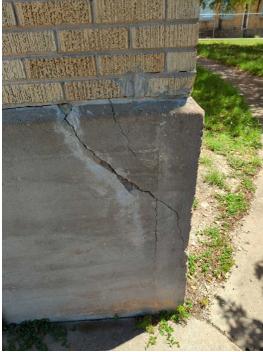
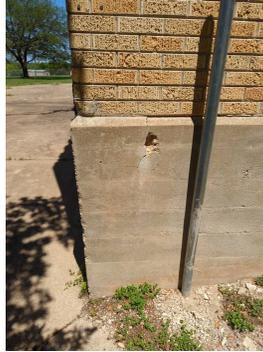
• **Cracking found in foundation in several areas. Most appear to be benign and only require repair.**  
 The cracking on the right side of the building has broken through interior walls and a shift toward the back is evident on the exterior corner. This is on both levels and coincides with the worse areas for foundation movement in front right corner. We believe they are probably related and recommend a structural engineer perform an evaluation of piers in this area and cracking found.

Cracking found in foundation in several areas. Back

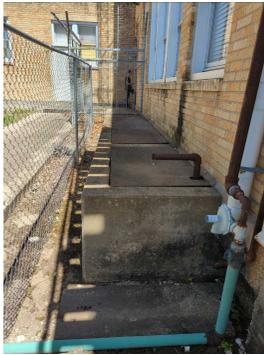
These concrete containers have water in them and may be part of the problem with moisture in basement

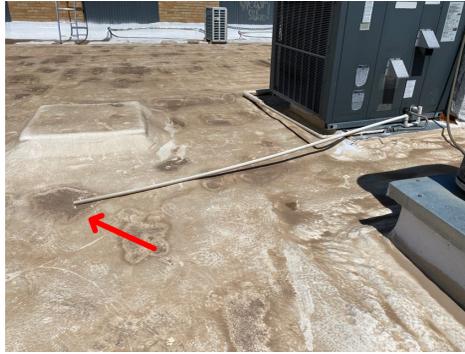
One or more condensation lines terminates on roof. #1

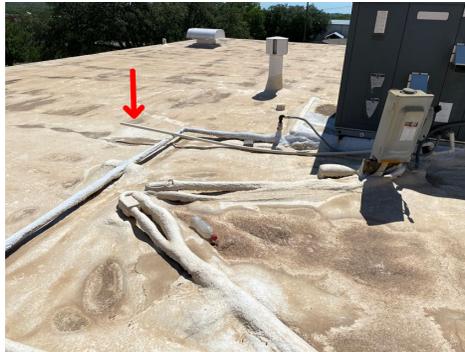
One or more condensation lines terminates on roof, #3

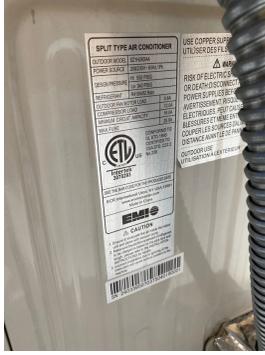
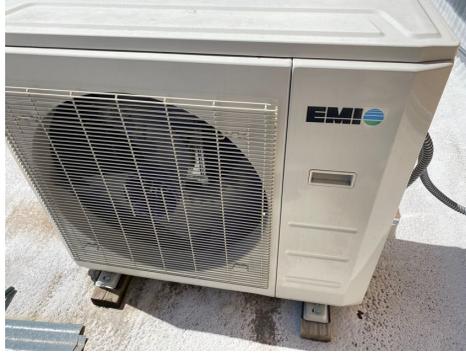
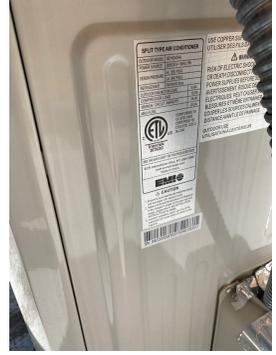
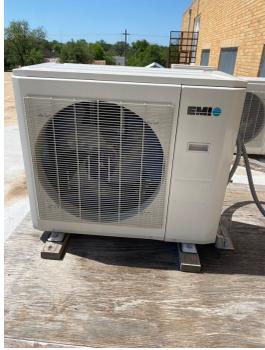
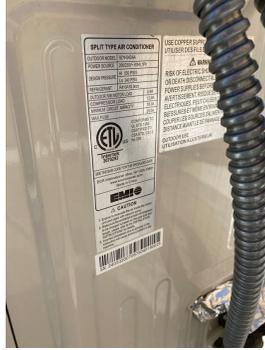
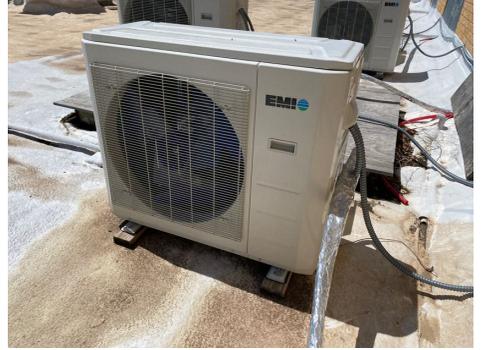
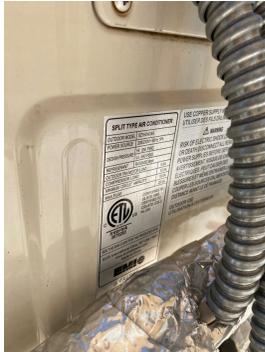
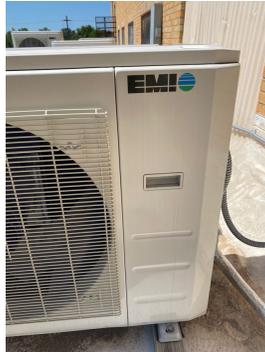
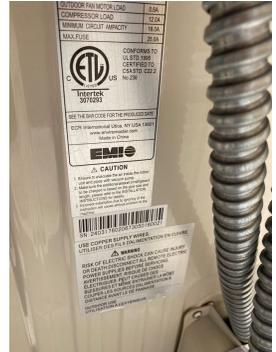
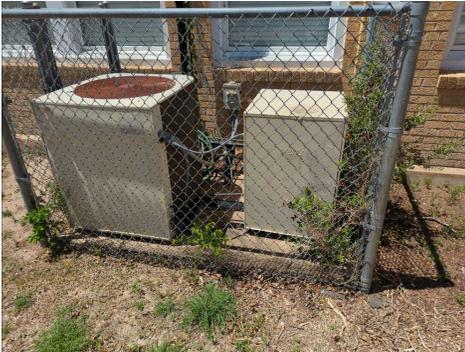
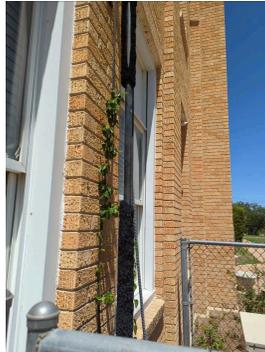
One or more exterior HVAC systems past useful life

One or more exterior HVAC systems are past useful life with deficiencies in freon line insulation, electrical wiring coming loose and a hazard and corrosion

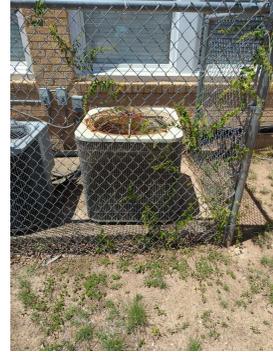
One or more exterior HVAC systems are past useful life with deficiencies in freon line insulation, electrical wiring coming loose and a hazard and corrosion

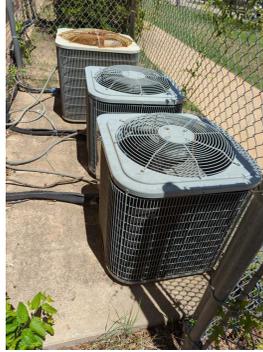
One or more exterior HVAC systems are past useful life with deficiencies in freon line insulation, electrical wiring coming loose and a hazard and corrosion

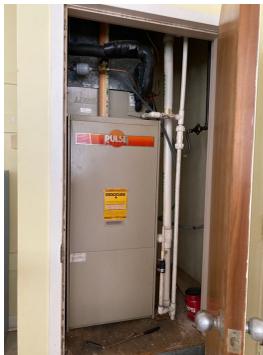
Example: Unit #1, front right classroom: 1985, Lennox R-22

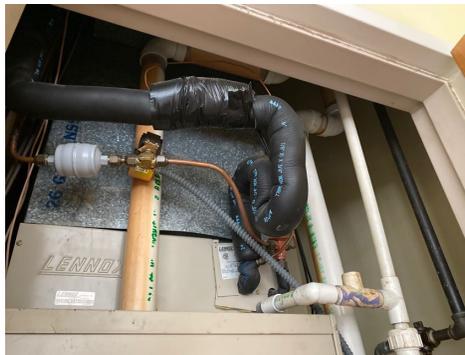
Unit #1, front right classroom: 1985, Lennox R-22

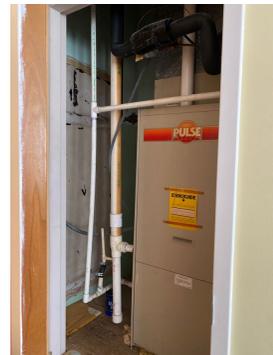
Example: Unit #2 in room 105 does not work. Window unit is in place

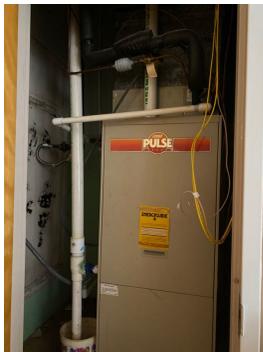
Example: Unit #3 in room 104: 1985, Lennox, R-22

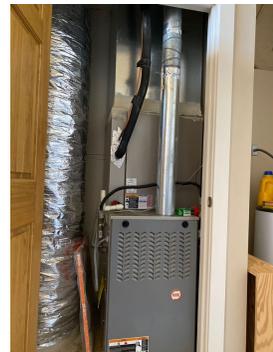
Fair right wing of building: 2010, Payne, R410A  
Missing sediment trap

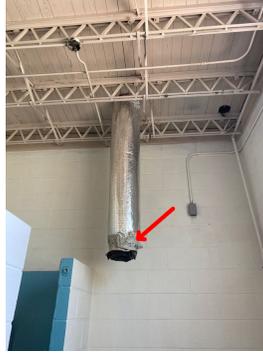
Open duct in sanctuary bathroom

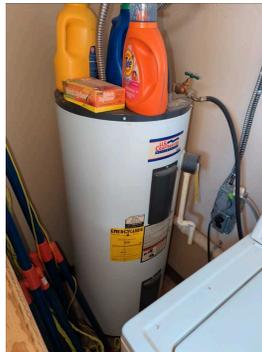
- It was noted that the water heater was not equipped with a corrosion resistant drain pan to discharge on the exterior. Right wing
- How water is not working in several sinks tested in main building.
- Temperature and pressure regulator valve line empties on floor in right wing

2010 US Craft master electrical water heater 50 gallons  
Right wing

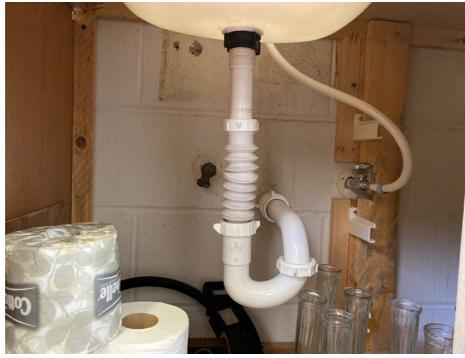
Flex drain pipe used under one or more sinks. This needs to be corrected by licensed plumber.

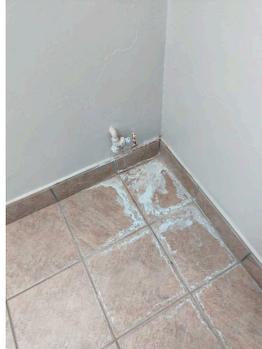
Appears to be a corroding plumbing spigot

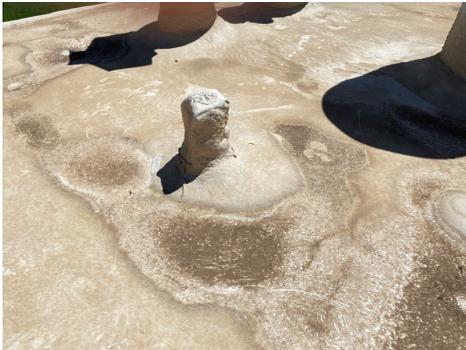
One or more plumbing vents on roof are covered with roofing material.

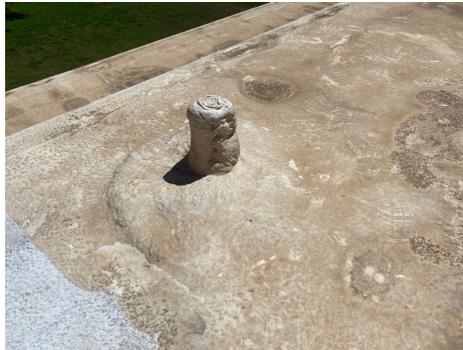
One or more plumbing vents on roof are covered with roofing material.

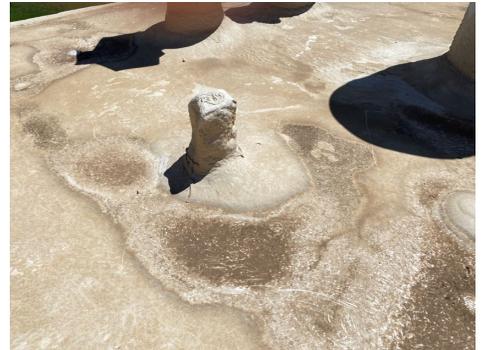
One or more plumbing vents on roof are covered with roofing material.

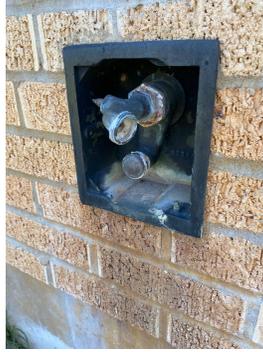
Exterior spigots missing insulation, antisiphoning device, and handle.

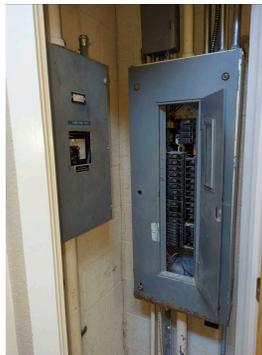
Electrical panel and shut off are installed incorrectly and need correction by licensed electrician. Safety hazards  
 Right wing of building

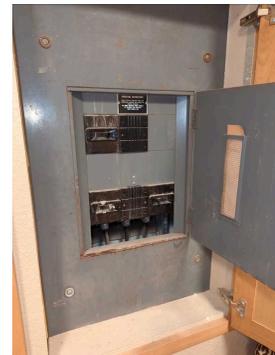
Electrical panel installed incorrectly and need correction by licensed electrician. Safety hazards  
 Right wing of building

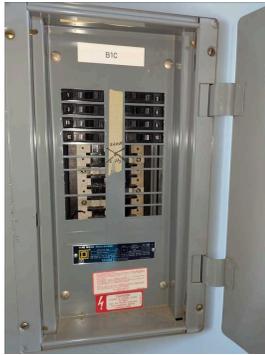
One or more electrical panels have breaker slot openings - several panels

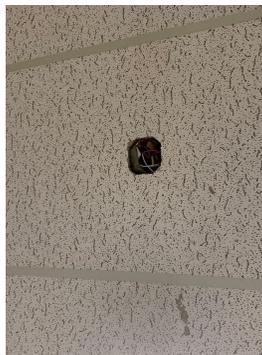
Open junction box in one or more places. Hallway

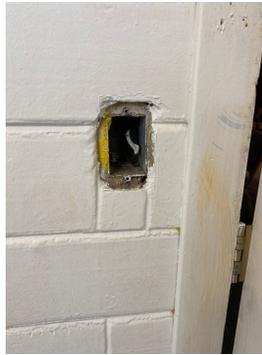
One or more switches, lights and outlets are no longer operable. Some have older cloth covers aluminum wiring.

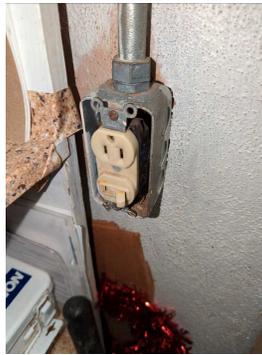
One or more electrical outlets missing covers. Recommend electrician evaluate

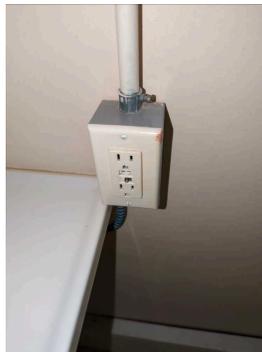
Bathroom in front has defective GFCI

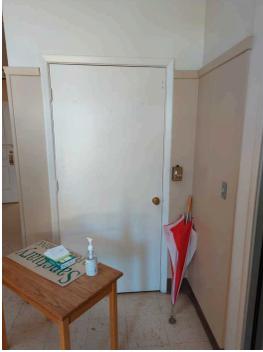
No key

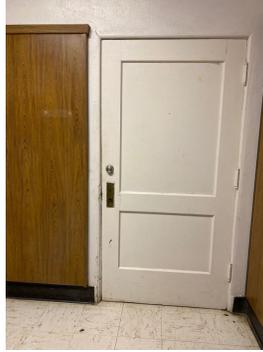
No key found for far left room upstairs

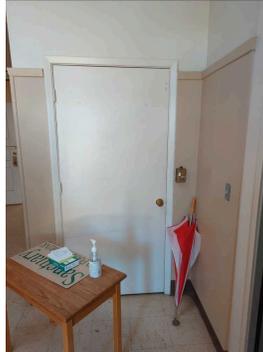
No key

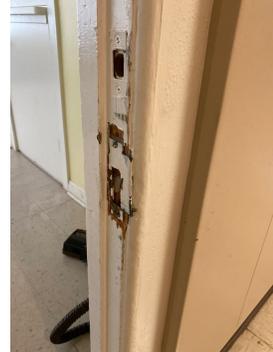
- One or more doors need repair:  
Front right classroom door  
Room behind sanctuary  
Back room of sanctuary
- One or more doors rubbing  
104

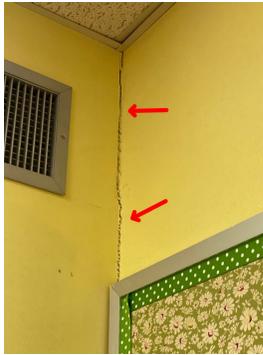
Cracking on one or more walls. Room 103

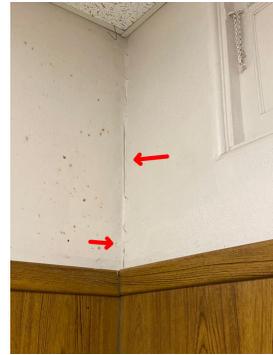
Cracking on one or more walls. Right upstairs hallway

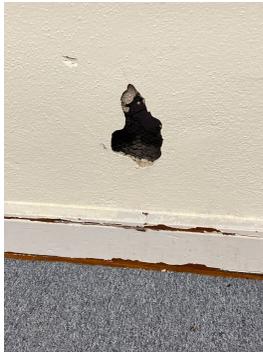
Hole in one or more walls. Upstairs right room

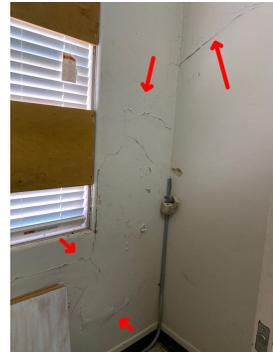
Cracks on right side of building. Upstairs

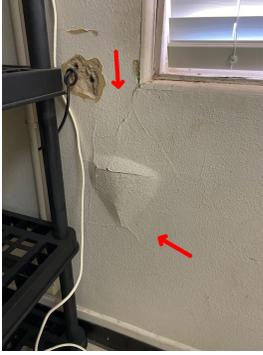
Cracks on right side of building. Upstairs

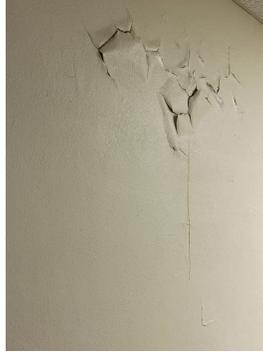
Water damage along wall in left stairwell.

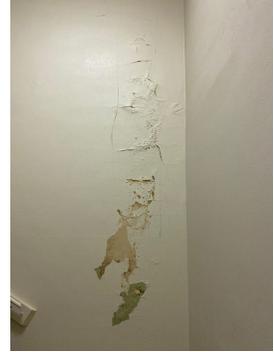
Water damage along wall in left stairwell.

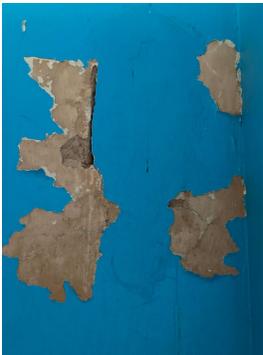
Cracking on one or more walls. Upstairs classroom #200

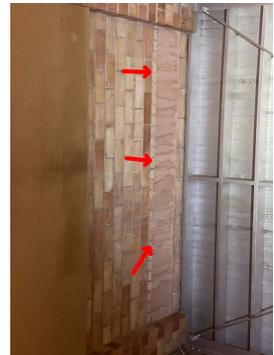
Water stains on wall coming from roof parapet. Along sanctuary wall

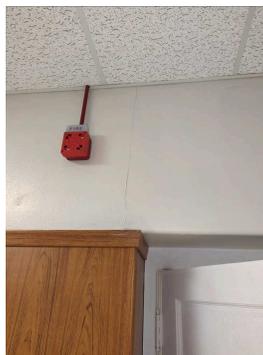
Cracks in interior walls on second floor. This is in hallway

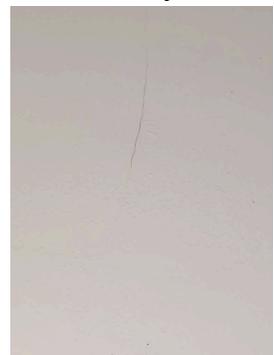
Cracks in interior walls on second floor. This is in hallway

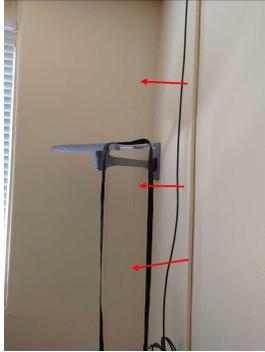
One or more cracks on right side front. Classroom kids and toddlers

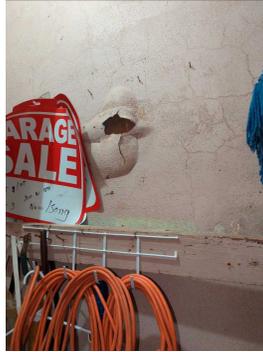
Stains/deterioration on wall downstairs utility closet

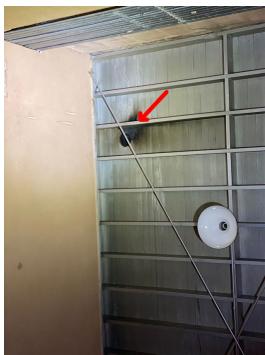
Sanctuary - unknown stain from combustible on ceiling.

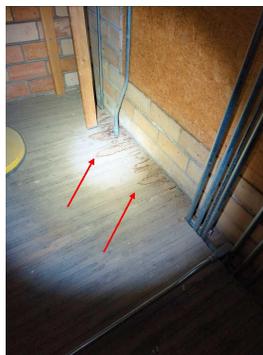
Water stains on floor above backstage

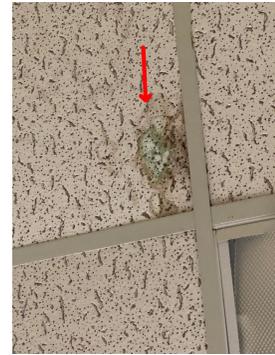
Ceiling tiles have water stains on one or more areas. Front right classroom

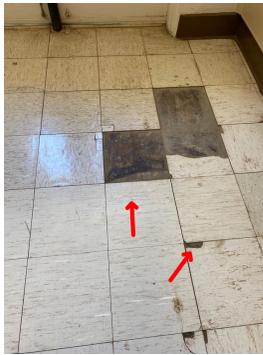
Tiles are cracked, broken, or missing in one or more locations. Hallway near middle exit

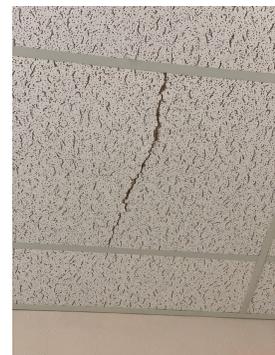
Tiles are cracked, broken, or missing in one or more locations.

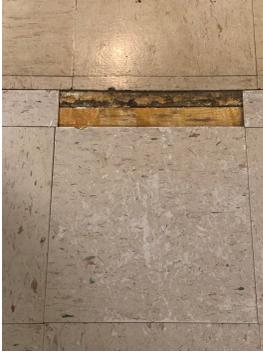
Tiles are cracked, broken, or missing in one or more locations. Front right classroom

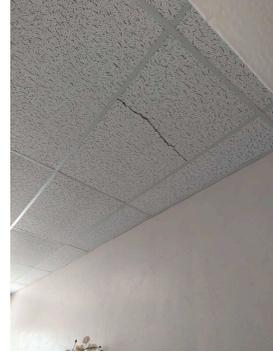
Tiles are cracked, broken, or missing in one or more locations. Upstairs

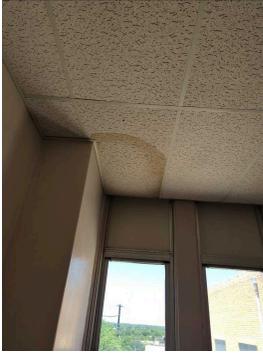
Ceiling in one or more areas have water stains. Some deterioration also. Upstairs

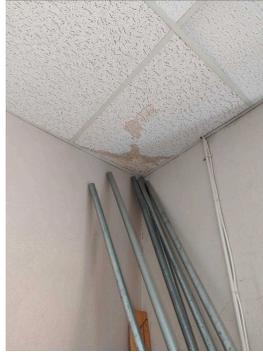
Ceiling in one or more areas have water stains. Some deterioration also.

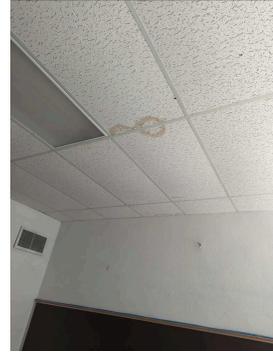
Ceiling in one or more areas have water stains. Some deterioration also.

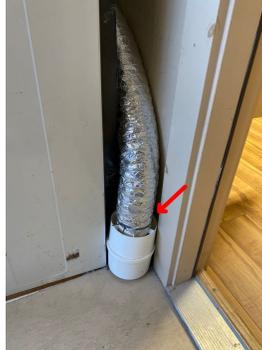
Dryer vent doesn't not have correct termination. Recommend repair.
